Richland County Recreation Commission

Americans with Disabilities Act (ADA) Transition Plan

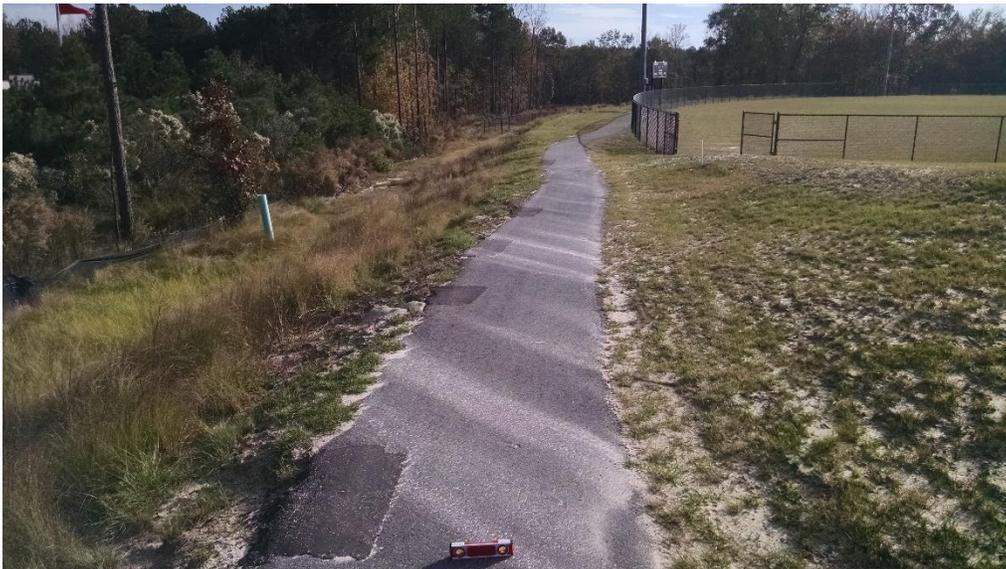
Problems: Two locations on the walking track had cross slope that was beyond the ADA’s limit. One location was near the beginning of the track moving counter clockwise from the main pedestrian entrance to the complex from the parking lot. The other spot is located between the two fields that boarder the school property. One can be seen in Figure 8 below. Both of these sections of the path showed signs of water erosion. It was unclear if the cross slope contributed to the erosion or was caused as a result.

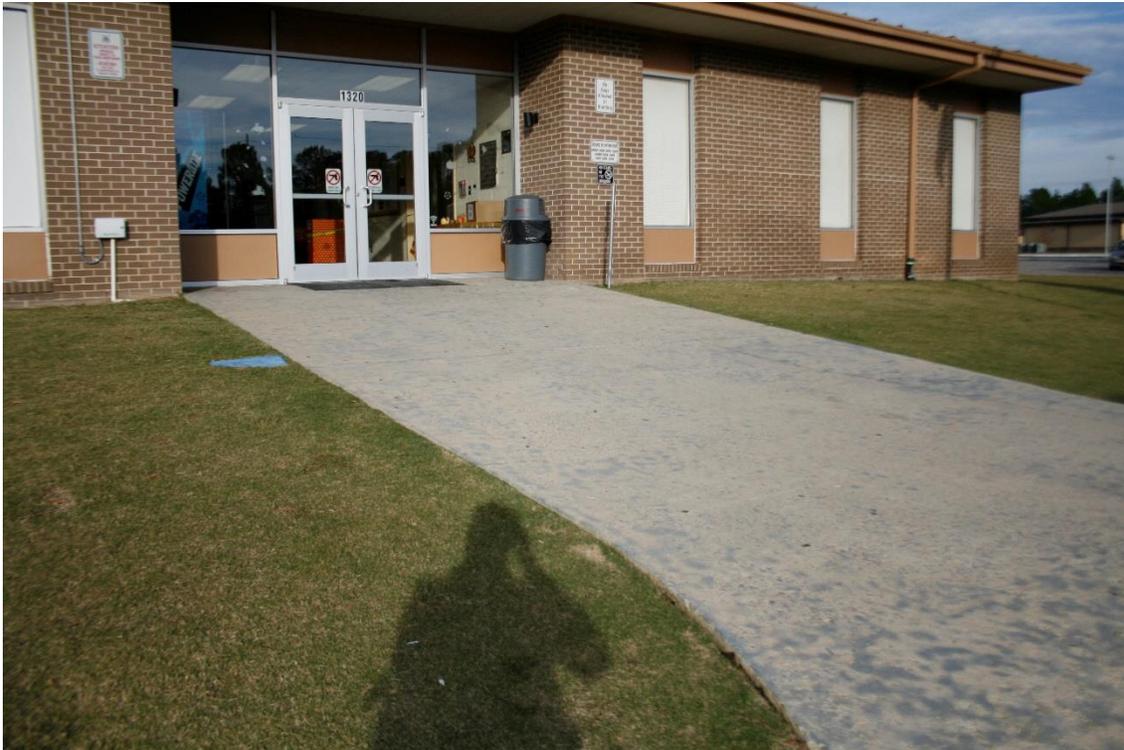
Problems: Parking pavement surface condition appears to be nearing the end of its lifespan but is not yet a significant barrier. Standard accessible parking spaces were sufficient for the number of total parking spaces available, but there were no van accessible parking spaces. The building entrance was up a non-compliant ramp that led directly to the door without landings (bottom, midway, or top). This ramp can be seen in Figure 9 below.

Due to this ramp, handrails would also be required. The double front door also required excessive force to open (10 lbs. one side and 13 lbs. on the other).

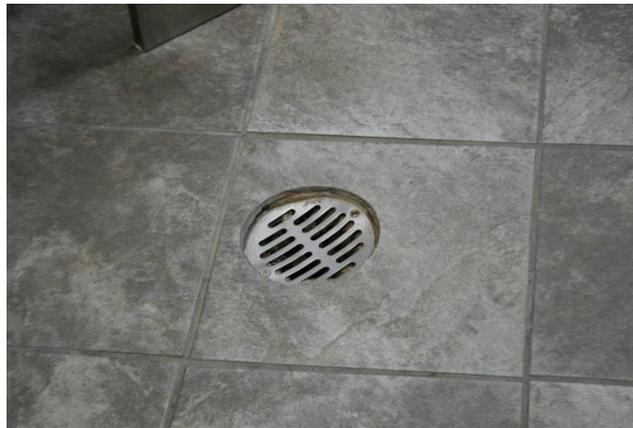
Problems: The men’s room had one urinal and it was mounted with its brim 23 inches from the floor. The women’s restroom had its mirror, soap dispenser, and door hooks mounted outside of the usable height. Floor drains were sunken significantly lower into the floor below the flooring material that caused a lip as seen in Figure 11 below.

1. Remount the urinal, soap dispenser, mirror, and door hooks in the useable range according to the ADA Standards above.
2. Install a new drain that is flush with the floor to remove trip hazard.

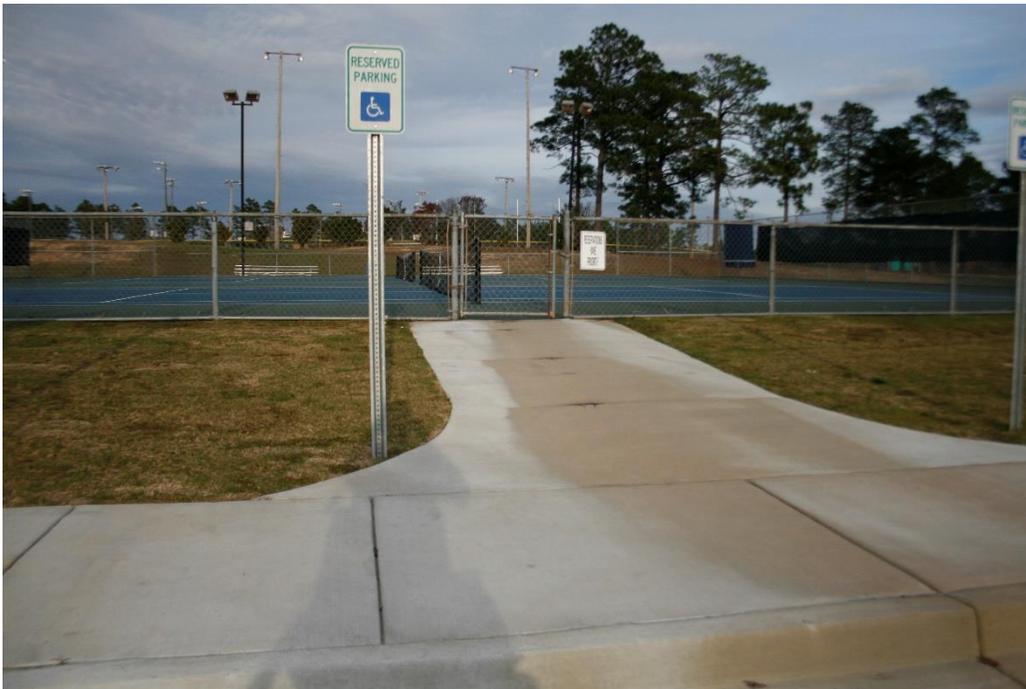
Figure 12

Problems: The curb cut from the accessible parking access aisle did not end at a landing. The slope up to the gate of the tennis courts is not manageable due to lack of clear floor space at the gate that is considered a “doorway” (Figure 12).

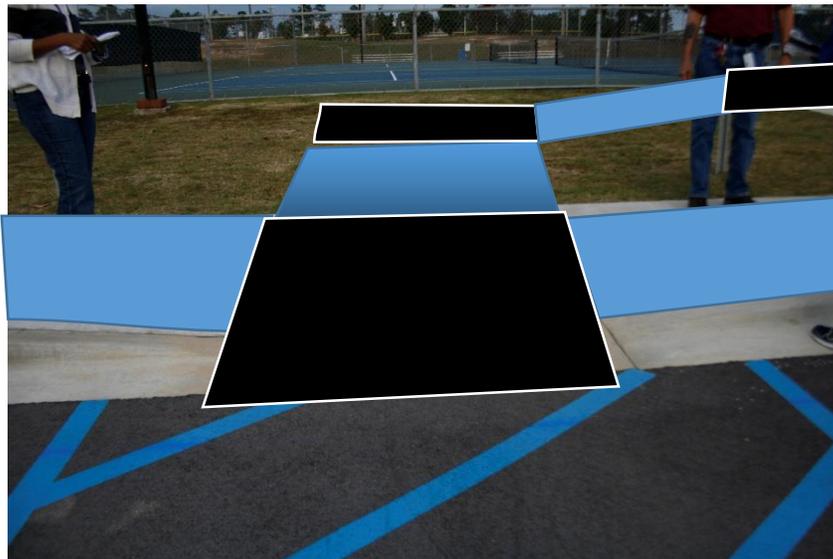
Figure 13 – Black rectangles are landings and blue shapes are ramps leading to gate and to sidewalk level

1. Replace the current curb cut with one that is level with the parking lot that has two ramps connecting this point with the adjacent sidewalk.
2. Install a third ramp that leads up at a slope at or just below 1:12 leading to a landing that is adjacent to the tennis court (while at a lower elevation). Construct another ramp run to reach a new landing with appropriate clearance where the tennis court gate is located. See Figure 13 below as a visual reference.

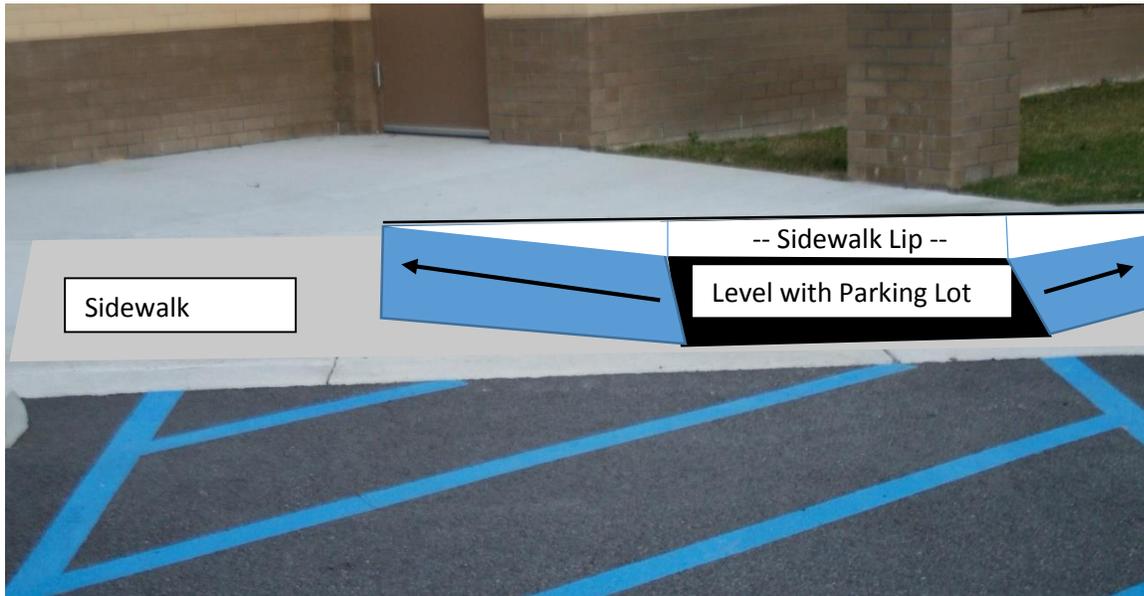
Figure 16 – Blue shaded area signifies ramp from level landing up to sidewalk in two directions

Reconfigure curb cut and sidewalk as seen in Figure 16 Below

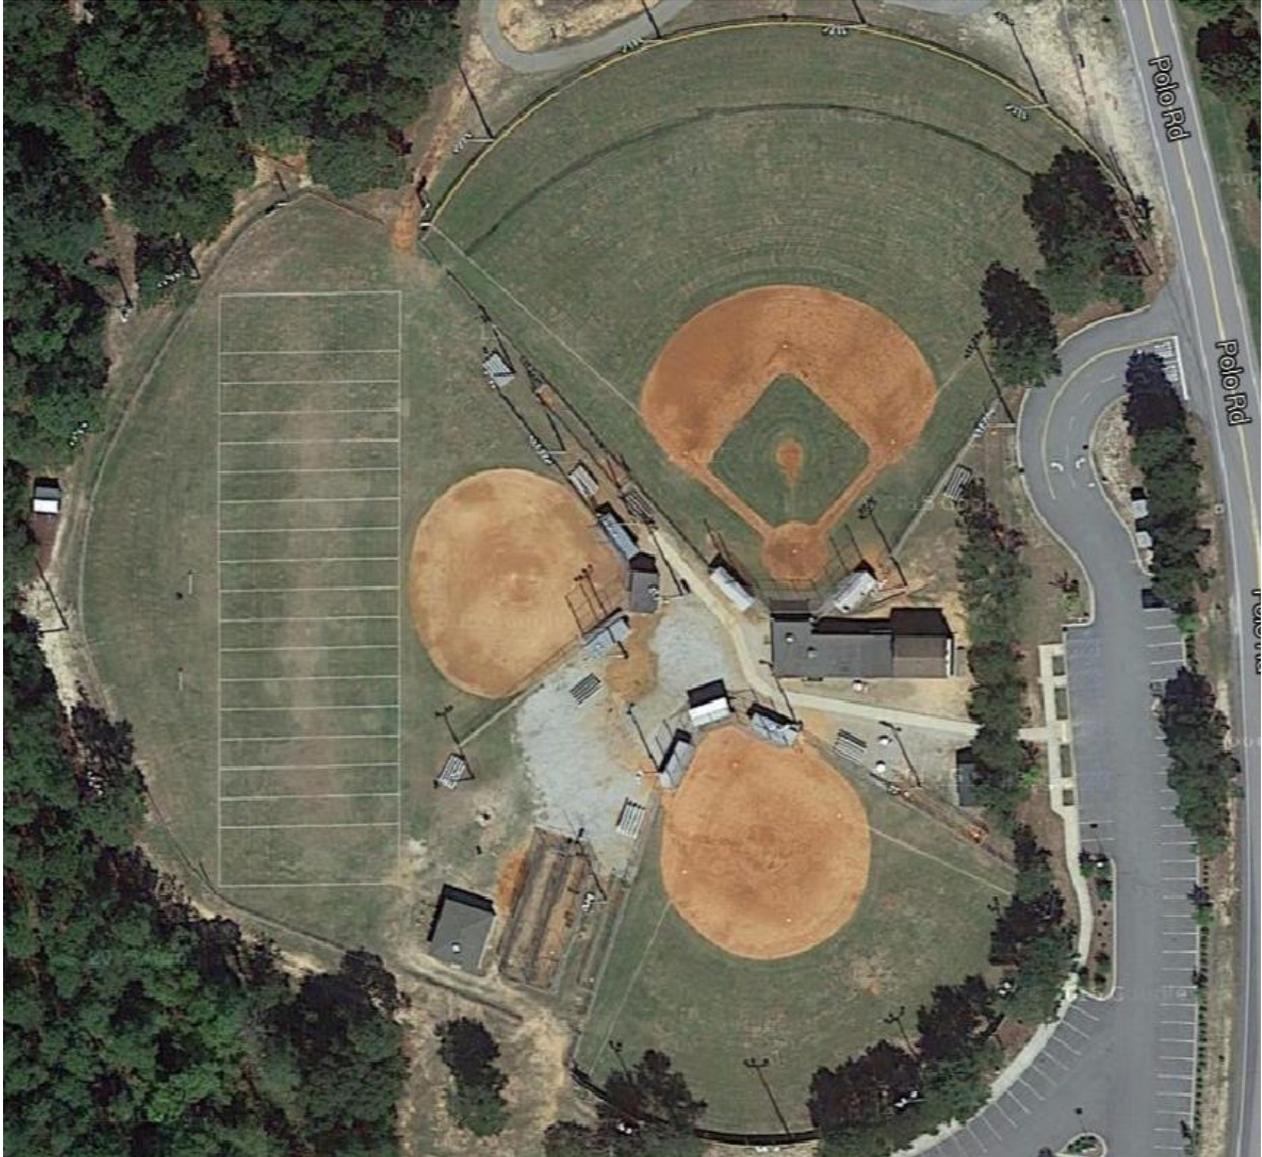
Problems: Dugout entrance doorways were only 29-30 inches wide. The dugout floors were paved but the concrete had lips both into the dugout and out onto the field. While there was a central sidewalk between the fields, all elements of the complex were not connected including spectator seating, and public restrooms as seen in Figure 19 below.

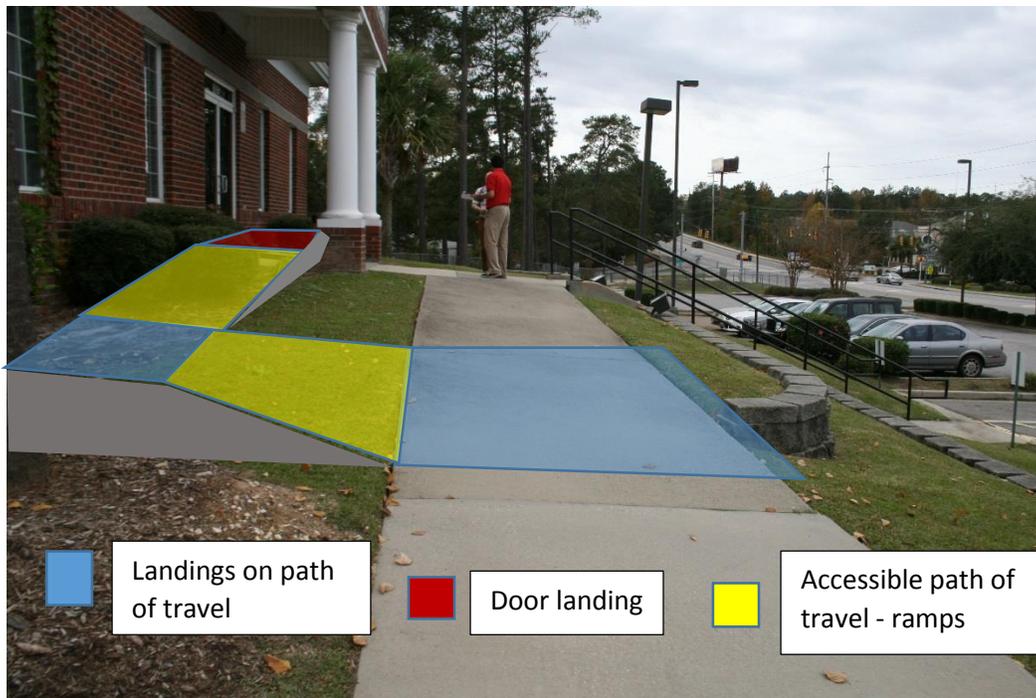
Figure 38 – Handrails would also be required

Repave the path of travel near the entrance door in order to install a flat landing as illustrated in Figure 38 below. Adjust the slopes of the ramps so they are compliant with ADA standards for ramps.

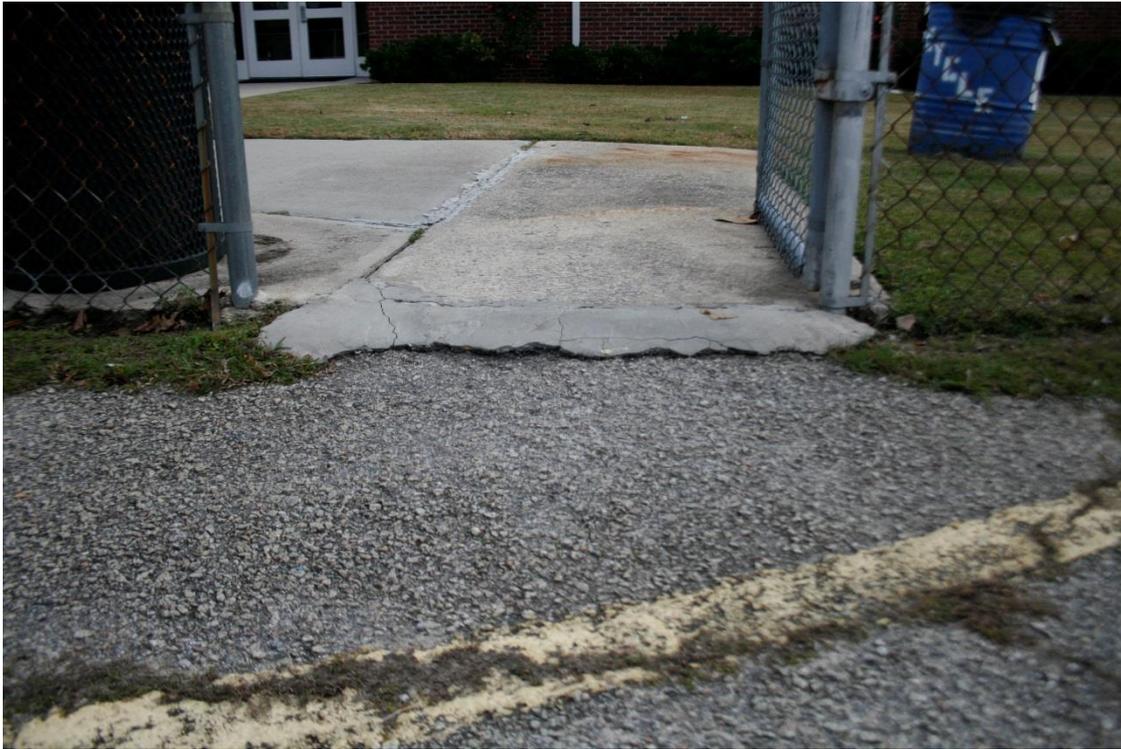
Figure 40

Problems: Curb ramp from the parking lot to the sidewalk into the area of the tennis courts and the pro shop has a slope of 12.5%, which exceeds ADA standards (Figure 40).

Repave the curb ramp to decrease the slope and to eliminate the vertical rise caused by the broken concrete.

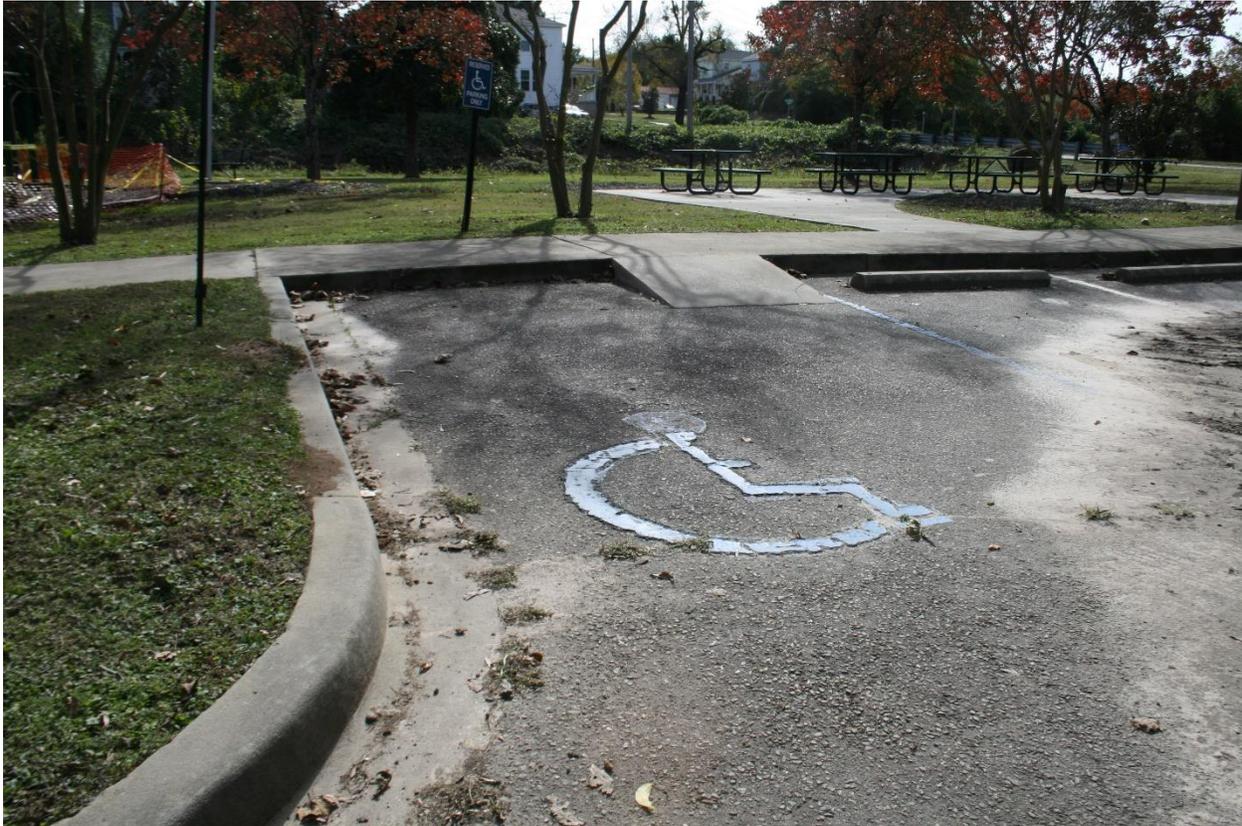
Problems: There is no access aisle for the van accessible parking space. The ramp from accessible parking space to the sidewalk is too steep and is located within the parking space. The sign designating accessible parking is mounted too low. All is visible in Figure 44 below.

1. The accessible parking space is wide enough to accommodate van parking. Although not required, it is recommended that the current sign be changed to designate this. If the space is marked as "van accessible" an access aisle that fits the dimensions mentioned above is required.
2. Repave the ramp from the accessible parking space to the sidewalk so that the slope is less steep. One way to achieve this is to increase the length of the surface of the ramp; extend the surface further into the parking lot so that the edge is still level with the adjacent sidewalk.
3. Raise the sign designating the accessible space to the appropriate height.

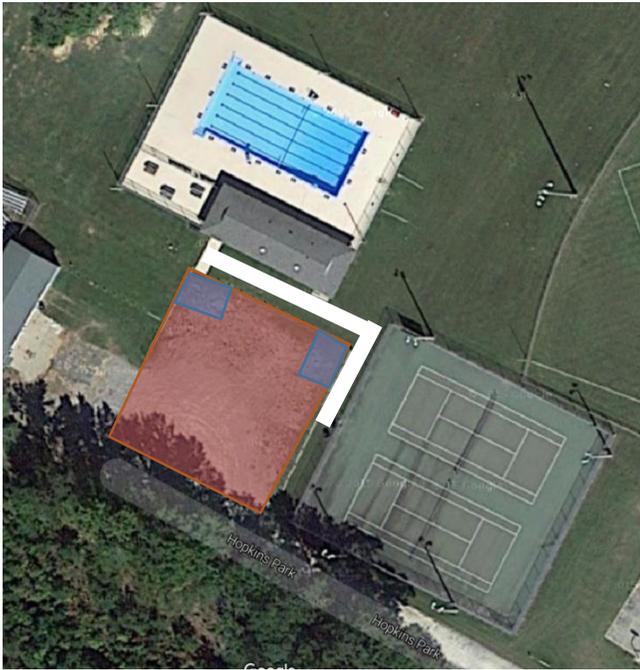
Figure 46: Red area - new parking lot, Blue areas - New Accessible parking, White line - Accessible path with curb cuts for parking

2. Pave the parking lot to be used by the pool and tennis courts. This will provide an accessible path to the tennis courts and from the tennis courts to the nearest restrooms (pool house). See Figure 46 below.

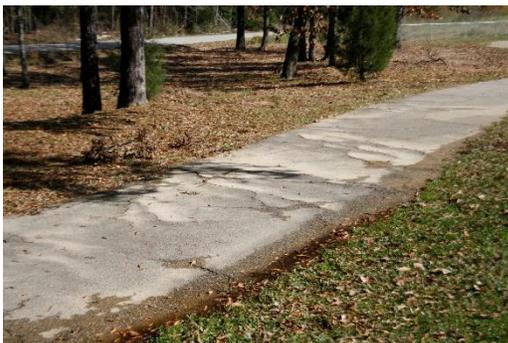
Figure 49

Problems: Throughout the path, there are many points where the tree roots have made the walking surface uneven and caused cracks and bumps to appear (Figure 49). The cross slope of the path was noted at 5.0% at one point. The slope of path was also noted as being too high for ADA compliance as seen in Figure 50.

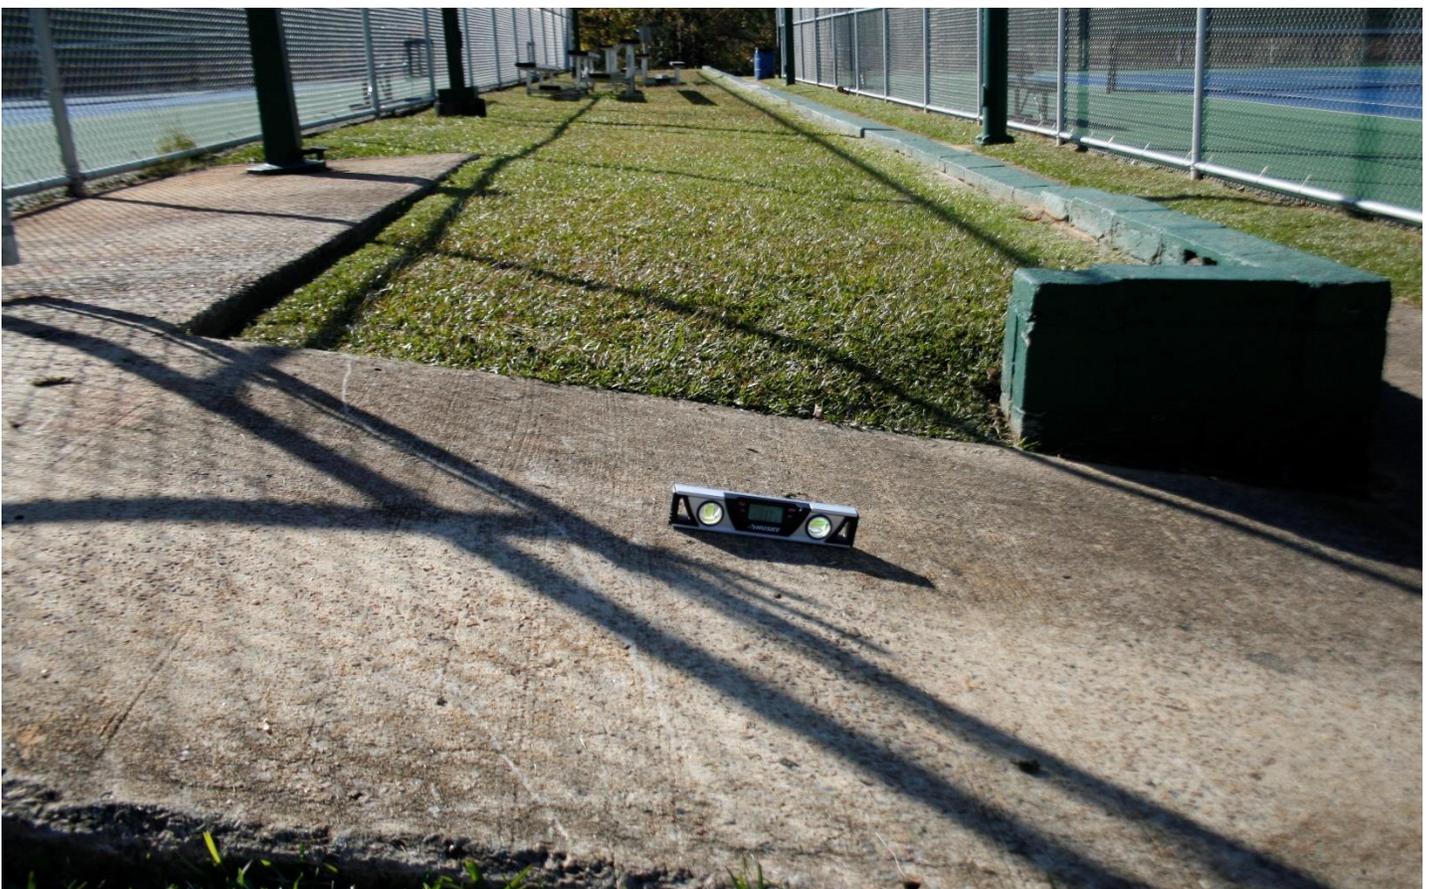
Figure 58

Nearby accessible parking lacked signage. Between the tennis fields is a dangerously steep ramp and spectator seating that lacks a firm surface and a path of travel (Figure 58).

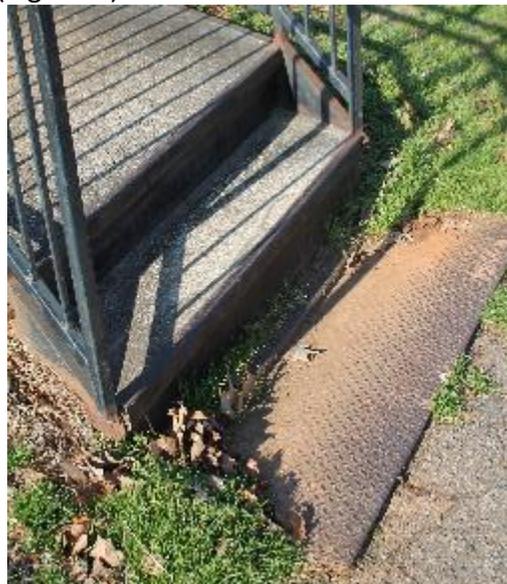
Figure 3

The path from the parking lot to the clubhouse entrance has a slope that ranges between 9% and 11.7%. There is a vertical rise at the bottom of the stairs caused by a metal plate that is beyond the standard limits (Figure 3).

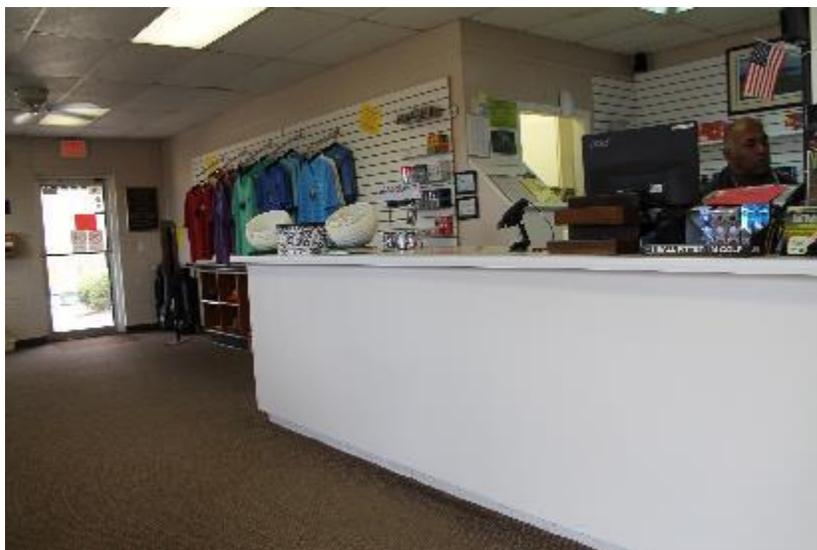
The service counter is at a height of 42 inches from the floor.

Figure 4 – high service counter and even higher merchandise.

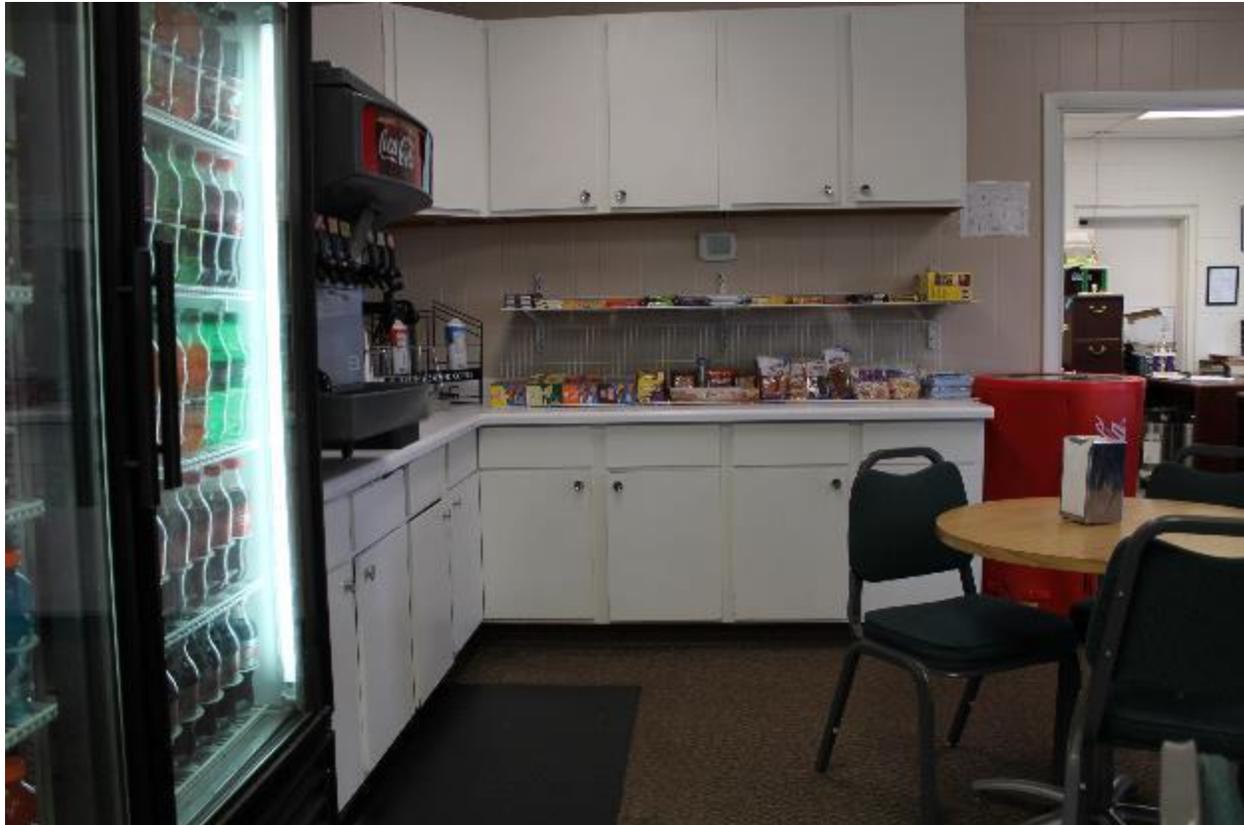
The operable parts of the soda fountain are at a height of 57 inches from the floor. The height of the candy bar racks to the floor is 54.5 inches. Many of the food counter heights were beyond the standard limit with most being at a height of 37 inches. There is no knee clearance for any of the self-service food counters as seen in Figure 5 below.

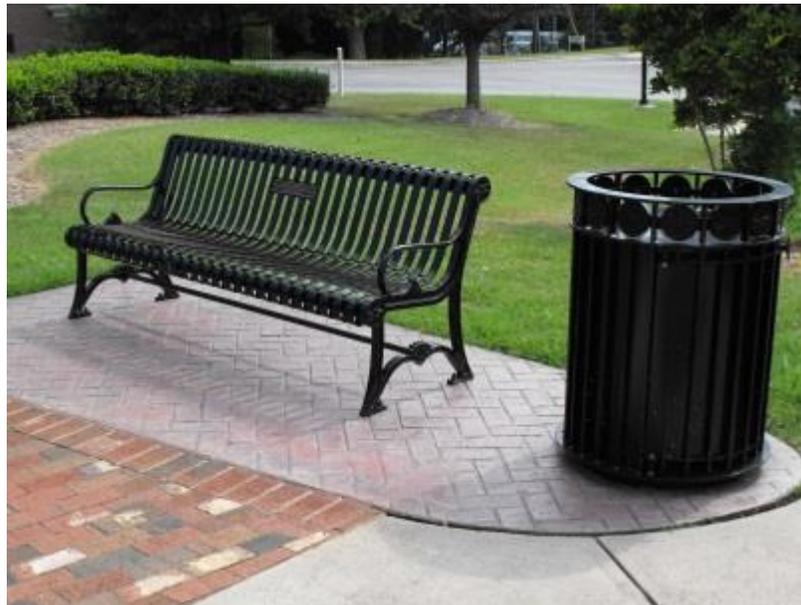
Figure 18 – Options for paving an accessible surface

1. Remove all rest features from these areas, pave each area with adequate clear ground space and replace the benches, water dispenser, and ball washers at appropriate heights.
