Richland County Recreation Commission

Americans with Disabilities Act (ADA) Transition Plan

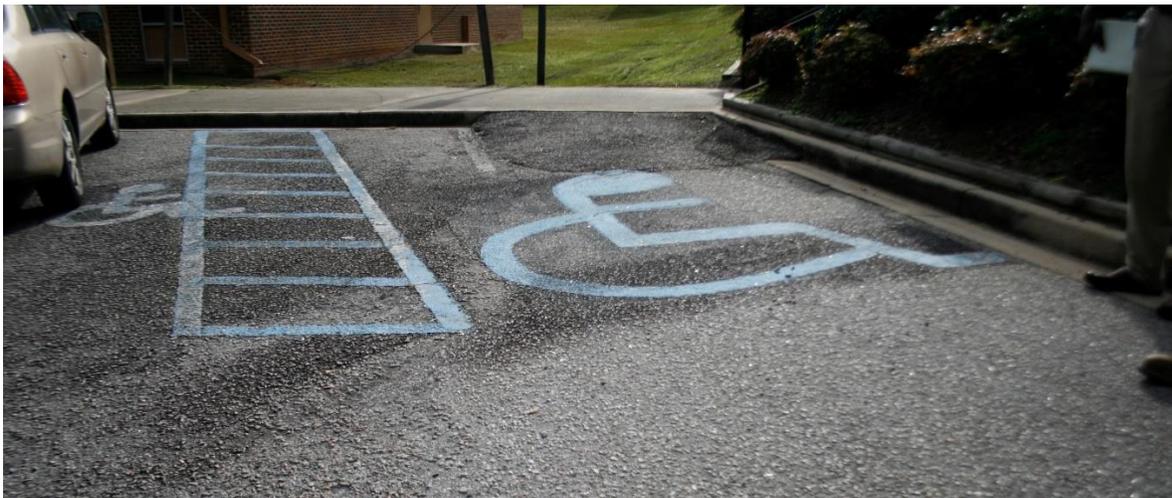
Problems: This lot is in fair shape but may be reaching the end of its lifespan. The current accessible parking spaces have a cross slope of 3.3%, the access aisle is too narrow, and the flares of the ramp are too steep. The ramp is also located within the parking space making it unusable when someone parks in the space. The accessible parking spaces were not marked with appropriate signs. This can be seen in Figure 1 below.

1. Relocate the accessible parking spots to the street-facing side of the parking lot where it is more level. When this is done the new access aisle should direct people to the new curb ramp referenced in recommendation two. When these new spots are created, make sure that they are in compliance with all ADA standards including those for signage and markings.

2. The current curb ramp can be used if the side is cut out and replaced with a curb with a discernable edge. This would eliminate the steep flare. The area that would include the modified curb cut should be marked as an access aisle and a clear path from the recommended accessible parking in Recommendation 1 of this section.

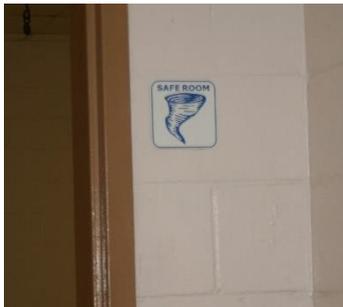
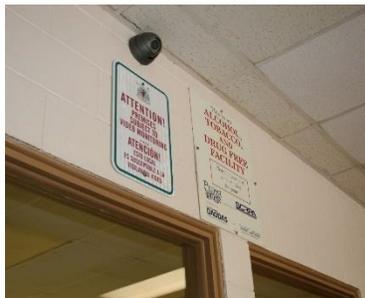
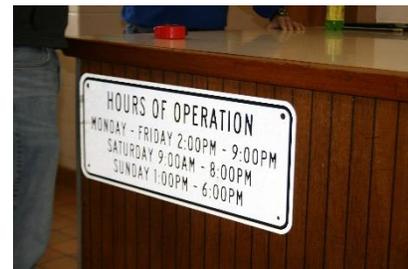
Problems: Service counter is three inches too tall at 39 inches. Many permanent office signs located in the lobby where inappropriately mounted (too high and too low), and they did not include braille or raised/recessed lettering (Figures 2, 3, and 4 below).

1. Cut out a section of the counter that would be less than 36 inches tall and at least 36 inches wide so that people who use wheelchairs can still have direct access to staff and information at the front desk.
2. Consider replacing current signage with signs that include raised lettering or braille. Custom signs are often much more expensive, but if the County needs to replace the signs in all of their facilities, volume may reduce per item cost. Mount new signs at a height that is 60 inches center.

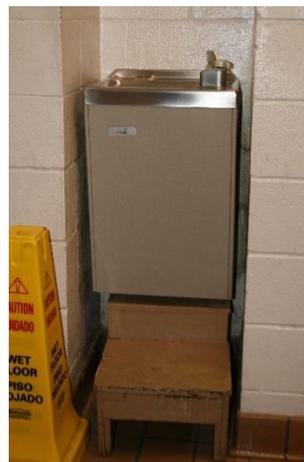
Figure 5

A brochure holder and the fire extinguisher both protruded into the path of travel. The chairs located in the lobby were an obstacle that prevents movable clearance to three of the rooms on site and the service desk. The vending machines on site had operable parts that were out of reach for parallel approach. The water fountain was an old style that did not have knee clearance and was mounted too high to be usable by all (Figure 5).

6. Replace the water fountain with an ADA Compliant model that allows for knee and toe clearance and install it at the appropriate height OR provide a cup dispenser that will allow people to get water from the fountain by hand. Cups would need to be dispensed no higher than 48 inches. This will provide program access and is only appropriate in the short term which the County prioritizes accessibility enhancements.

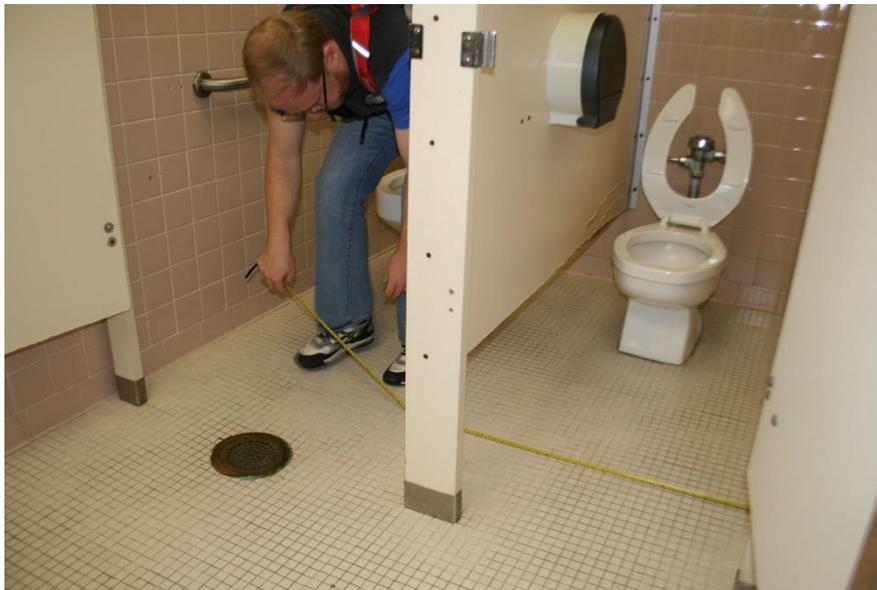
Problems: Both restrooms had two toilet compartments and neither is wheelchair accessible as seen in Figure 6 below.

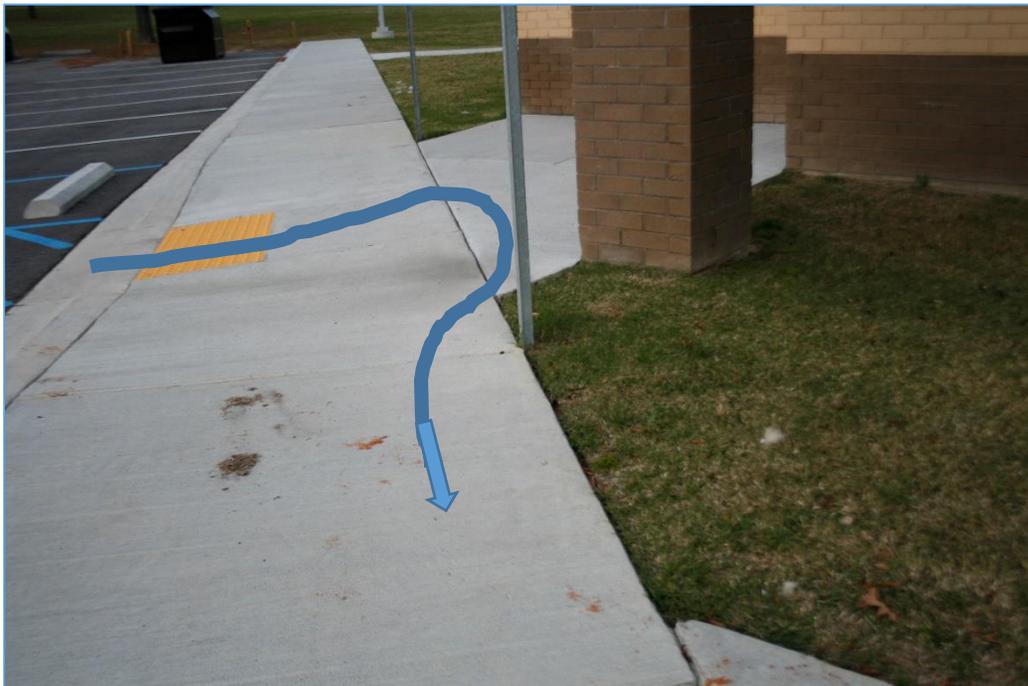
Problem: Curb cut leads to hard/awkward turn as seen in Figure 14 below.

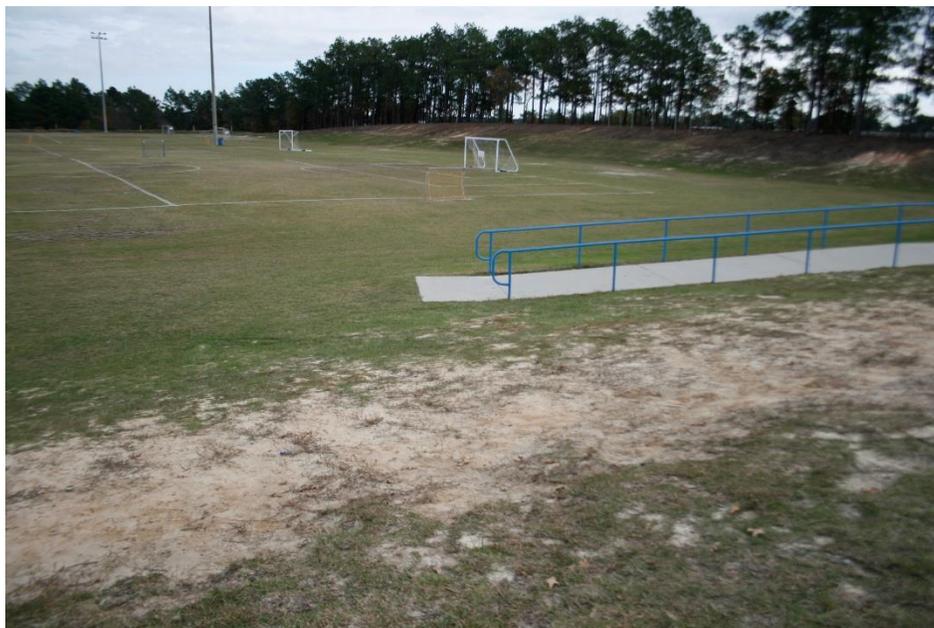
Figure 17

Problems: Curb ramps had inconsistent slopes ranging from 5.6 to 10%. The sidewalks connecting curb cuts had cross slope measured at 2.3%. The accessible path leading from parking into the fields ends abruptly without connecting to anything (Figure 17).

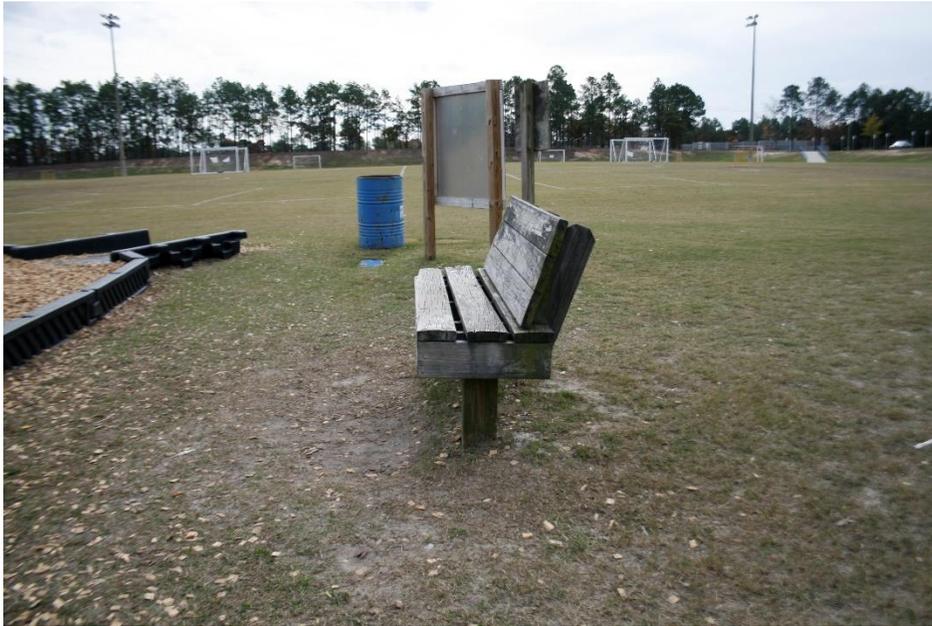
Figure 18

Problems: The benches along the perimeter were not connected to any path of travel and were mounted at 23 inches and 26 inches tall. The playground fill material is not accessible.

1. Lower benches if necessary after the path of travel has been paved. Benches should be 17-19 inches from the floor surface.
2. Replace playground fill material with one that meets accessibility and safety standards.

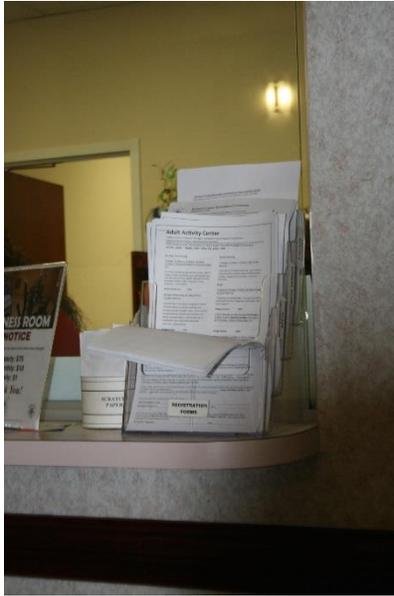
Figure 21

Problems: The brochures toward the back of the brochure holder on the counter are too high to reach from the surface of the counter (Figure 21).

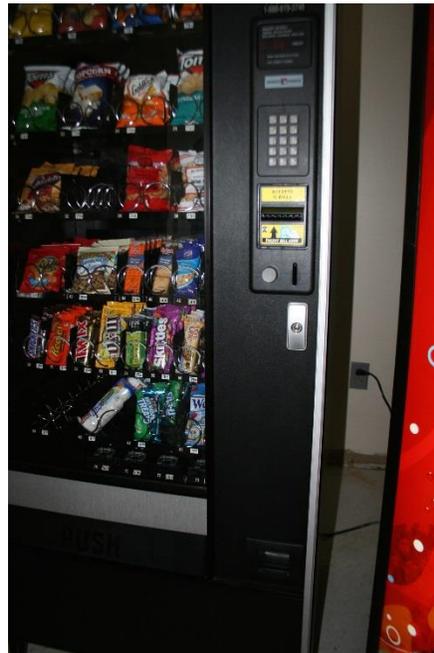
Figure 23

Problems: The operable parts of both vending machines are too high to access. The drink machine operable part is 51 inches from the floor. The food machine operable part is 55 inches from the floor (Figure 23).

1. Consult with vending company to see if the machines can be replaced with ADA compliant models or limit options to three with one at each height allowing people with disabilities access to the same options.
2. In the meantime, if this site is regularly staffed during open hours, a vending machine sign that is ADA compliant suggesting the citizens to ask the staff for access and a personnel policy may achieve program access.

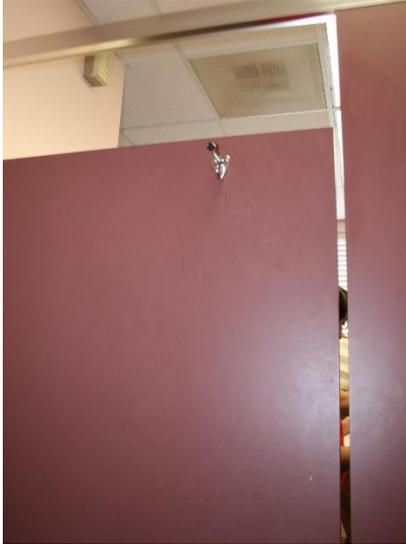
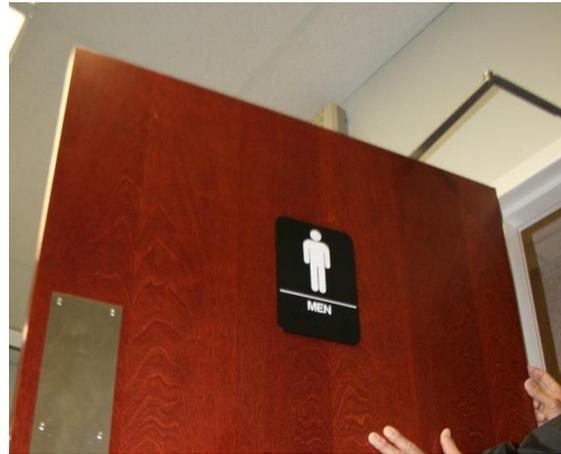
Problems: The operable part of the soap dispenser is too high and too far from the edge of the counter. The width of the accessible stall is too narrow; it is 31.5” wide. The coat hook of the accessible stall is too high at 61 inches (Figure 24). The sign designating the men’s room is on the door of the restroom (Figure 25).

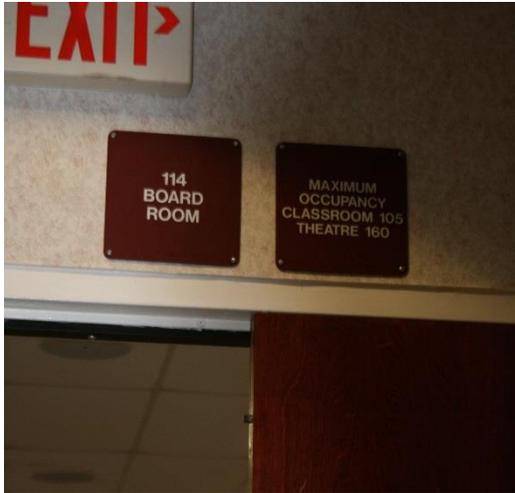
Figure 29

Problems: The signs designating the board room and maximum occupancy are mounted above the door (Figure 29). There is a vertical rise at the transition of the accessible ramp to the stage of a height of at least 1 inch as seen in Figure 30.

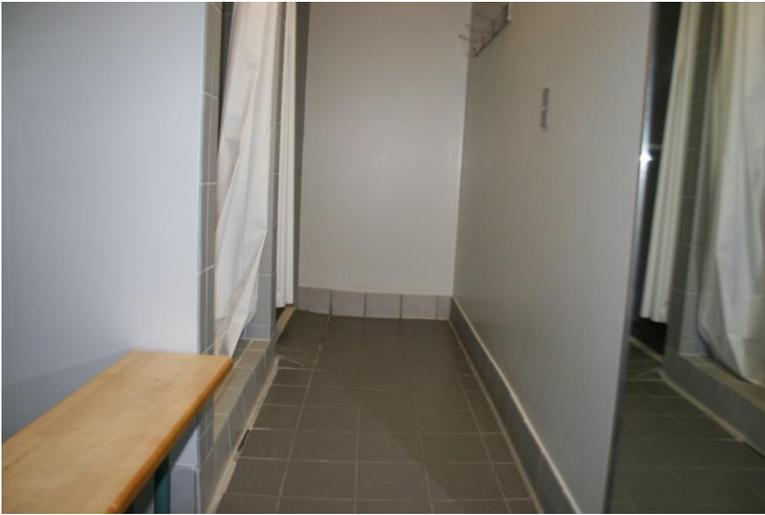
Figure 31

Problems: Accessible path of travel to showers has a 34 inch clearance (Figure 31). The accessible shower stall area is 36.25 inches by 33 inches. The shower control height has a range of 49 to 51 inches. The shower wand is too high and has a twisting knob to control it (Figure 32). The locker door latch design is inaccessible (Figure 33). The sign designating the men's room is mounted on the door and lacks an accessible notice.

1. A redesign of the showers and bathroom space may be required to achieve accessibility. Recommend consultation with a contractor to redistribute space or locate another space for an accessible shower stall.
2. Lower the shower wand height and replace the shower wand so that the controls are compliant with 309.4.

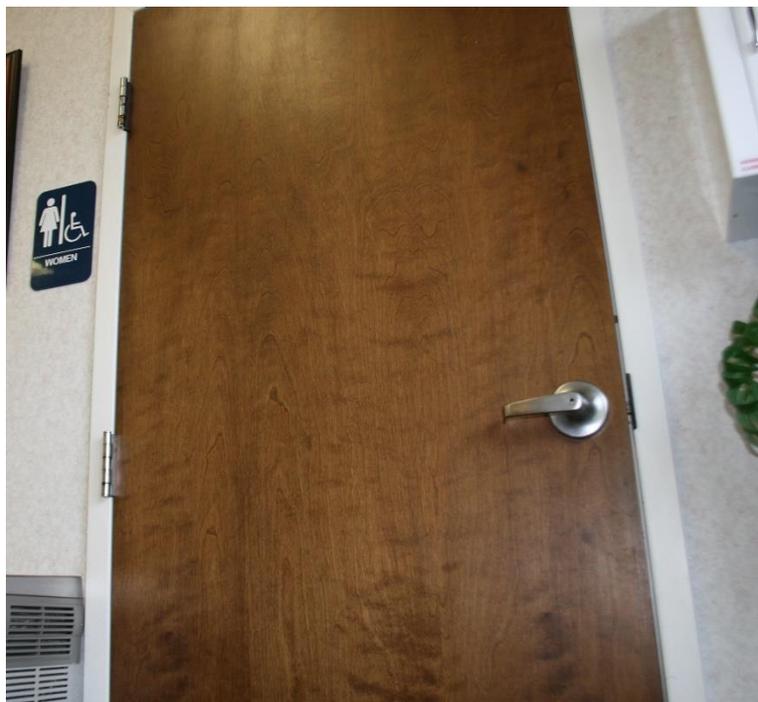
Figure 37

Problems: Sign is on wrong side of the door; soap dispenser is too high – 55.375 inches from floor to operable part (Figure 37).

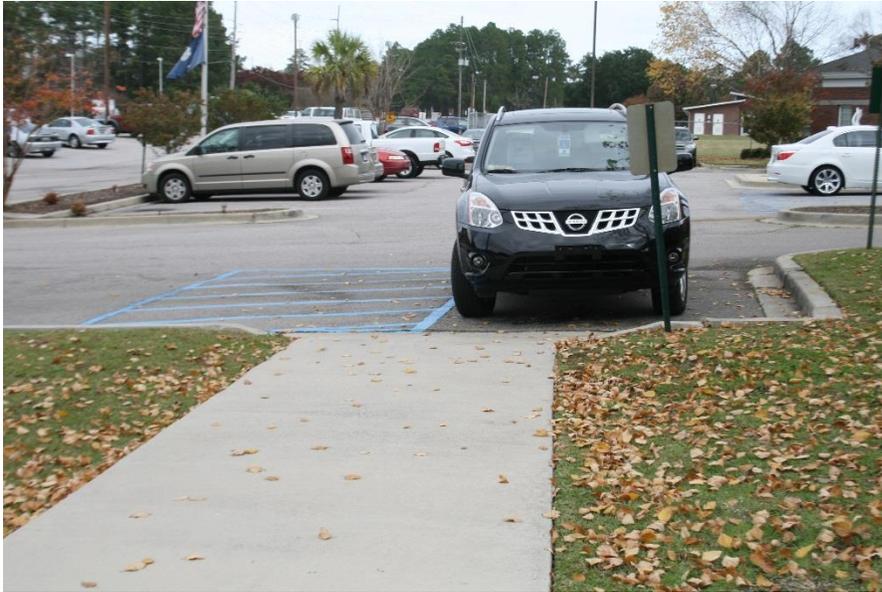
Figure 39

Problems: Access to the accessible route adjacent to the accessible parking space can become obstructed if a car or van is parked in the space as seen in Figure 39.

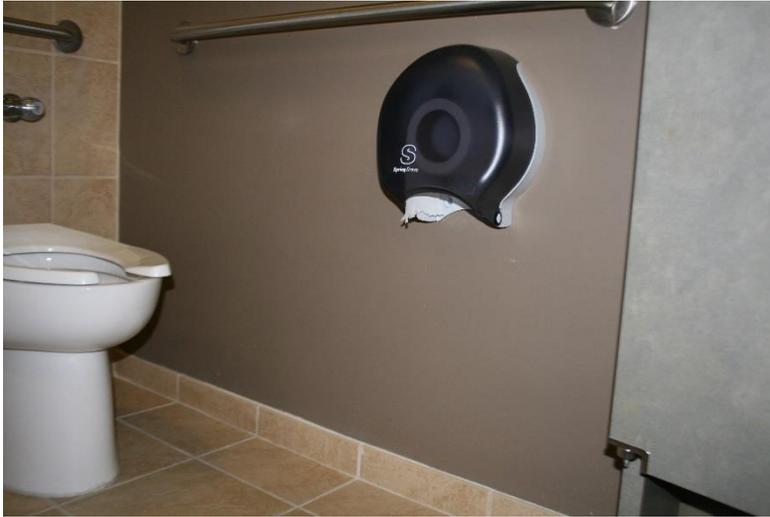
Figure 42

Problems: The soap dispensers are located too high at 57 inches from the floor to the operable part. In the women's restroom, the toilet paper dispenser in the accessible stall is too far from the toilet at 18.25 inches away (Figure 42).

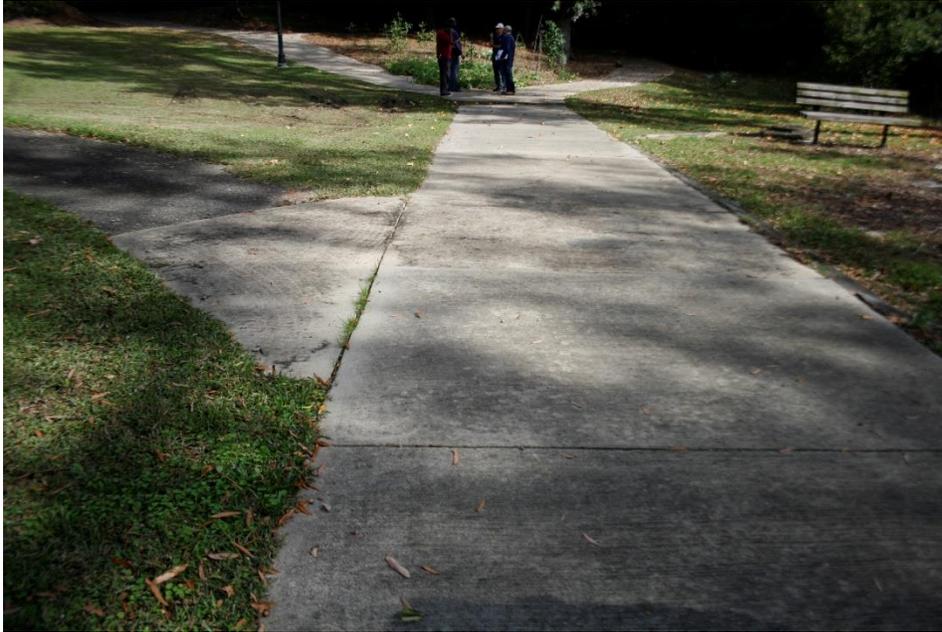
There are two of these located in the park. When these intersections exist they often follow the slope of the adjoining sections. With more than two sections the slope may compliment one path while causing cross slope for another direction of travel as seen in Figure 45 below.

Problems: The slope at these intersections is too steep for the accessible path of travel.

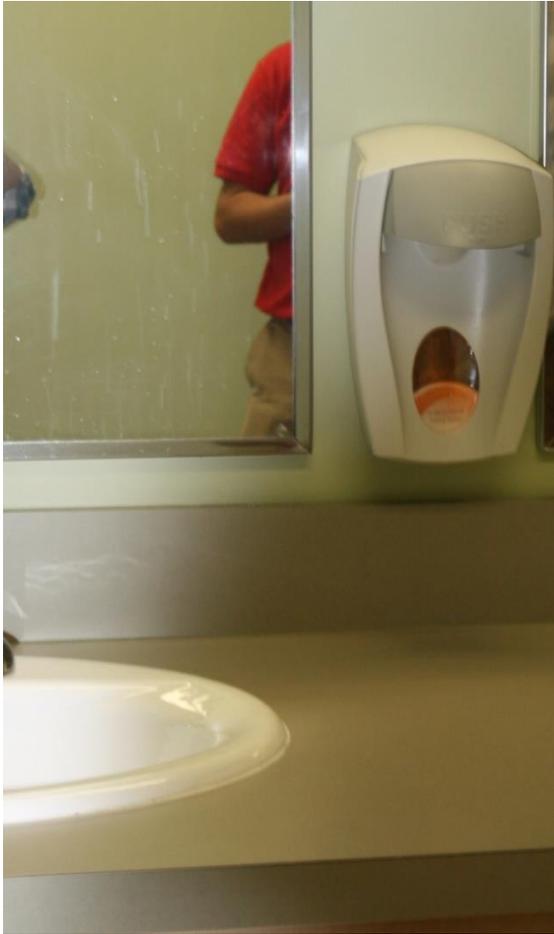
Figure 47

In the clay studio, movable tables were placed too close to afford clearance. The restrooms in this facility were nearly compliant as their soap dispensers were too far and too high to reach (Figure 47), and the men’s room had an inaccessible latch in the wheelchair accessible stall.

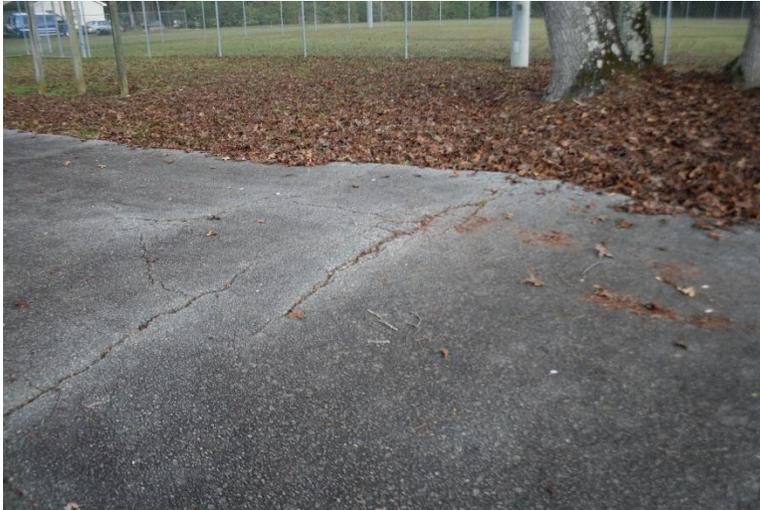
Figure 48

Problems: The dugouts were not accessible due to narrow doorways and a step up onto the paved surface. Spectator seating was placed on a solid surface and did not have an accessible path to get to them. The picnic area, grill, trashcans, benches, and playground all lack an accessible path of travel directly adjoining the element. The playground fill material is not ADA compliant (woodchips). The walking trail has areas where roots have pushed up through the asphalt surface (Figure 48).

1. Pour concrete paths to connect all park elements in the immediate area (not the tennis court or pool due to recommendation for paved parking).
2. Move elements that are out away from paths (Blue RCRC trashcan) closer to the path of travel to shorten needed sidewalk spans.
3. Pour concrete pads for spectator seating. The whole bleacher does not need to be on concrete as long as there is space for seating and clearance in the front row. The front benches of bleachers are within the appropriate range and may be reserved for accessible seating in addition is wheelchair spaces.
4. Replace playground fill material with an accessible alternative.

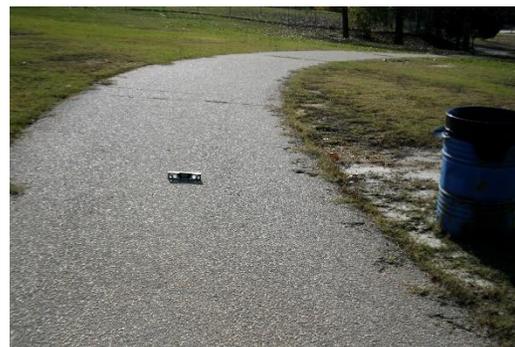
Figure 50

Problems: Throughout the path, there are many points where the tree roots have made the walking surface uneven and caused cracks and bumps to appear (Figure 49). The cross slope of the path was noted at 5.0% at one point. The slope of path was also noted as being too high for ADA compliance as seen in Figure 50.

Repave or seal the sections of the sidewalk that are broken. Recommend repaving the entire section of the asphalt path since there are multiple uneven points in it as well. Another option for the asphalt path is to remove the paving and designate the unpaved path as a nature trail which does not have to meet accessible standards since it is no longer an accessible path of travel.

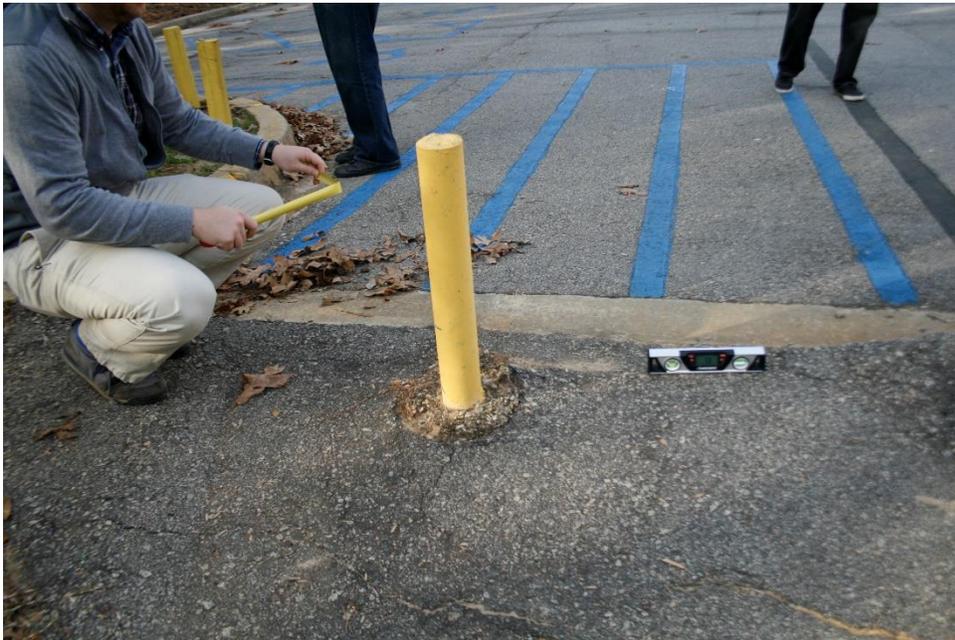
Problems: The accessible parking located at the front of the building did not include signage. The accessible parking around the left of the building had signage that was too low and the curb ramp was built into the access aisle. The accessible parking around the right side of the building had a pole in the middle of the access path with excessive cross slope as seen in Figure 52 below.

1. Place compliant signage over the accessible parking at the front of the building.

2. Raise the accessible parking signs around the left side so that the bottom is at least 60 inches off the ground.
3. In this same area, reconfigure the curb ramp. It may be possible to install a recessed ramp into the corner of the access aisle and still have the required clear minimum width for use of the access aisle. See figure 53 below as a reference for the ramp style.

4. Remove or reposition the barricade pole to allow for at least 32 inches of clearance on one or both sides.
5. Lay new asphalt or concrete around the right side of the building where parking lot connects with the parks paths. While this work is in progress, allow for clearance on either side of the barricade pole OR
6. Remove the accessible parking from this section of the parking lot. The accessible parking at the front of the building and around the left side would still exceed the minimum required. If parking is moved, this path connector does not need to be accessible.

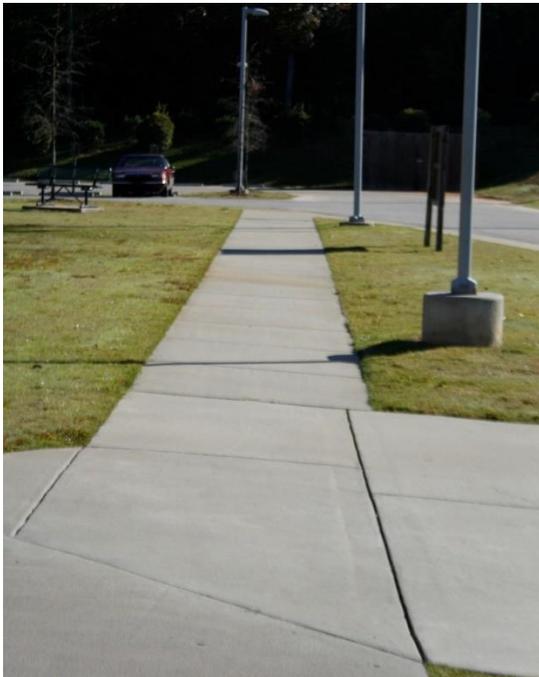
Figure 56

Problems: The cross slope is too much of the sidewalk between the playground and the roadway. (Figure 56)

Replace this section of sidewalk that will have no more than 1:48 cross slope.

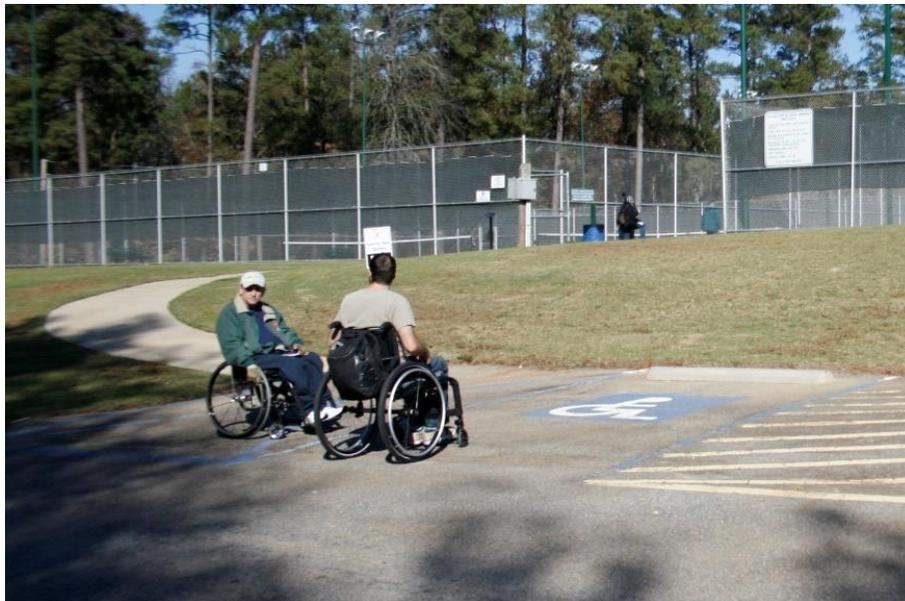
Figure 57

Problems: There is no accessible path of travel to any of the tennis courts because the path from the building includes stairs and the path from the parking area has too much slope and cross slope (Figure 57).

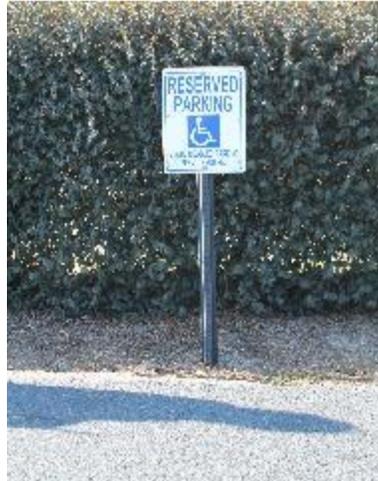
There are 2 parallel accessible spaces for a parking lot with 101 spaces. The signs designating these accessible spaces are mounted too low as seen in Figure 1 below.

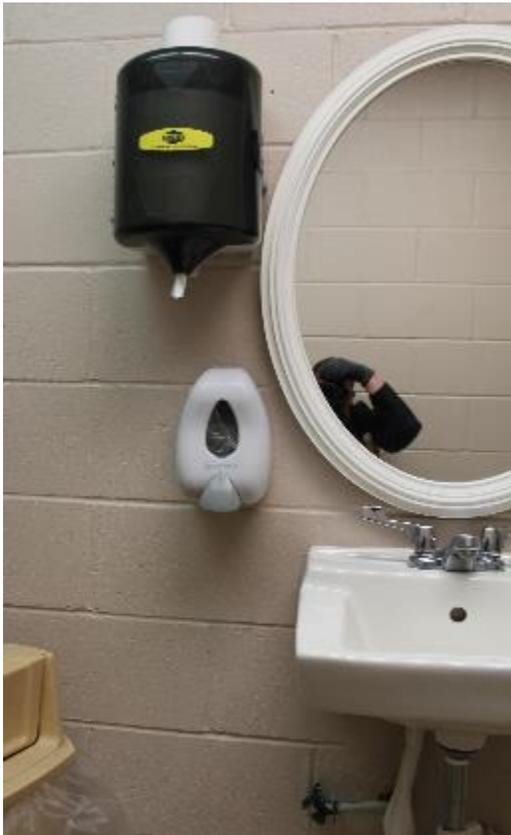
There is a vertical rise in front of doorway to restroom. The door for the accessible stall opens into the accessible stall. The paper towel rack is mounted at a height of 54 inches. The toilet paper dispenser is mounted too high at a height of 44.5 inches from the floor and 29 inches from the surface of the toilet. The sink is at a height of 34.5 inches. The sign designated this restroom is mounted on the door.

Figure 8 – High Dispenser

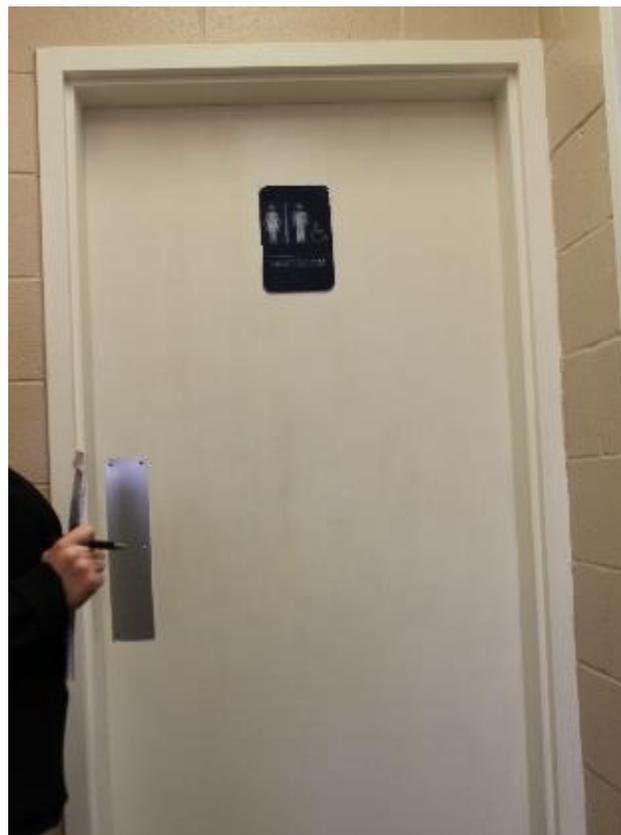
Figure 9 – Door-Mounted Sign

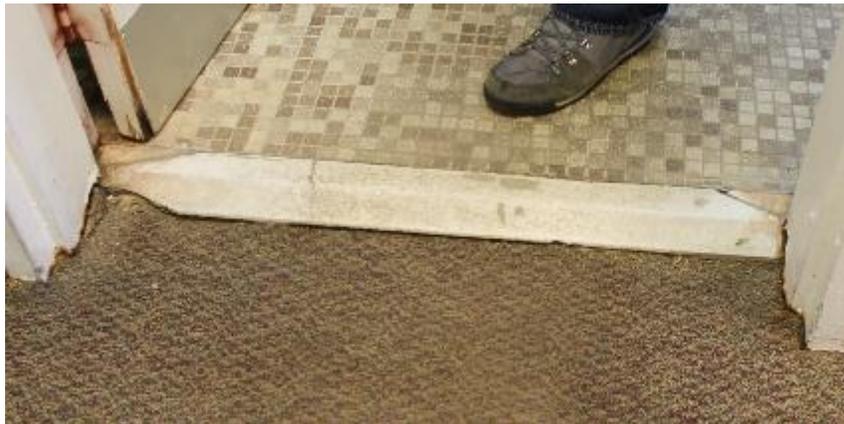
There is a vertical rise in front of the door (Figure 11). The between the trashcan and the wall there is a clear width of just 31 inches. The clear width between the sink and that same wall is 34 inches. The paper towel dispenser is mounted at a height of 56 inches. The urinal is mounted 6 inches too high. The toilet seat measured at 15.5 inches tall. There is no accessible stall. The toilet stall has one grab bar, but requires two for ADA compliance. The sign designating this restroom is mounted on the door.

Figure 11 – Tall Threshold

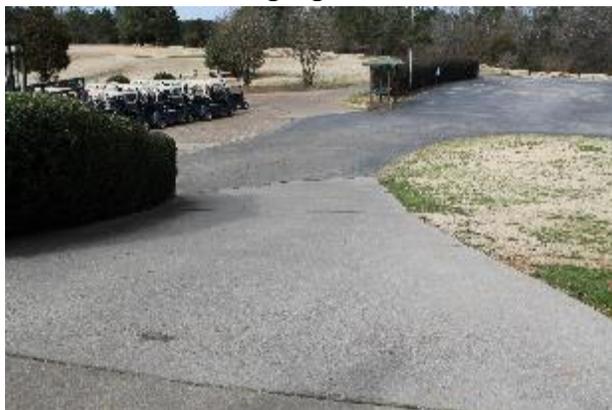
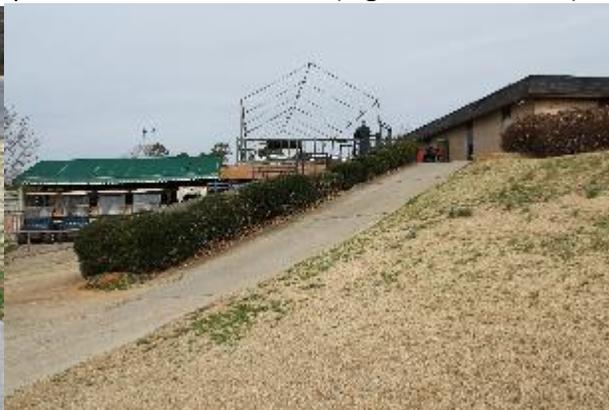
The uncovered picnic area has tables with fixed seating and does not include any accessible seating at picnic tables for those who cannot transfer. Leaving this area to play golf is only accessible while using a golf cart because the slopes are in excess of 20% (Figures 12 and 13).

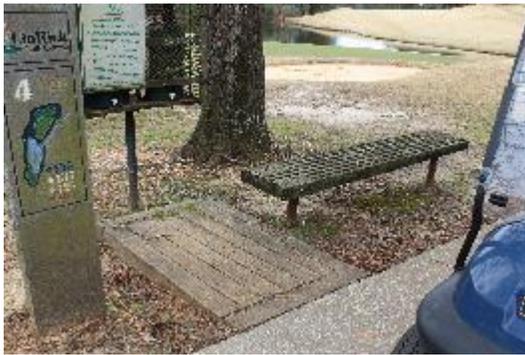
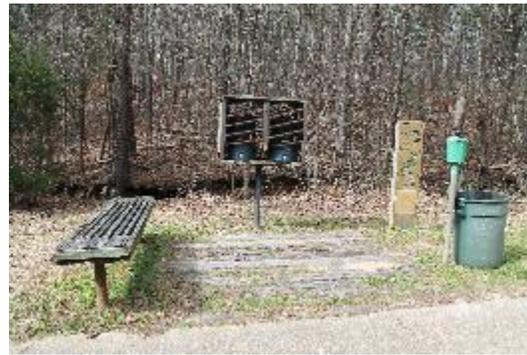
Rest areas were located at holes 4, 7, 13, and 16. While laid out differently, all of the rest areas had similar barriers. Figures 16 and 14 below are from holes 4 and 16 respectively.

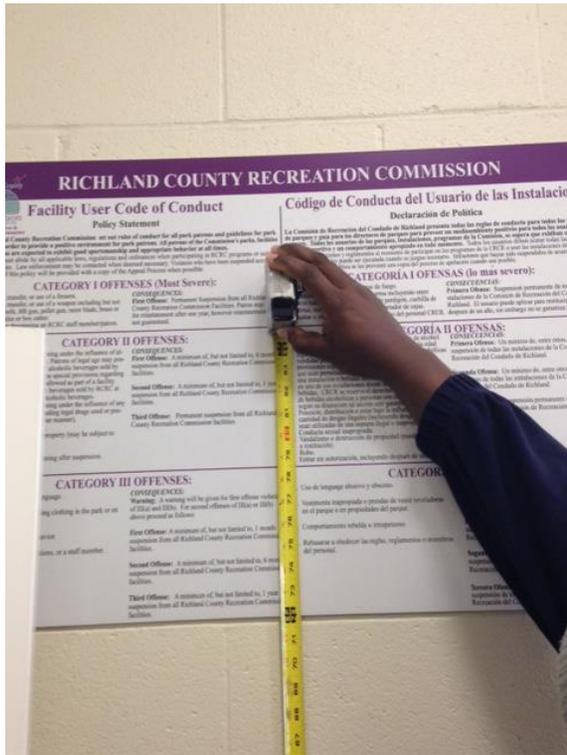
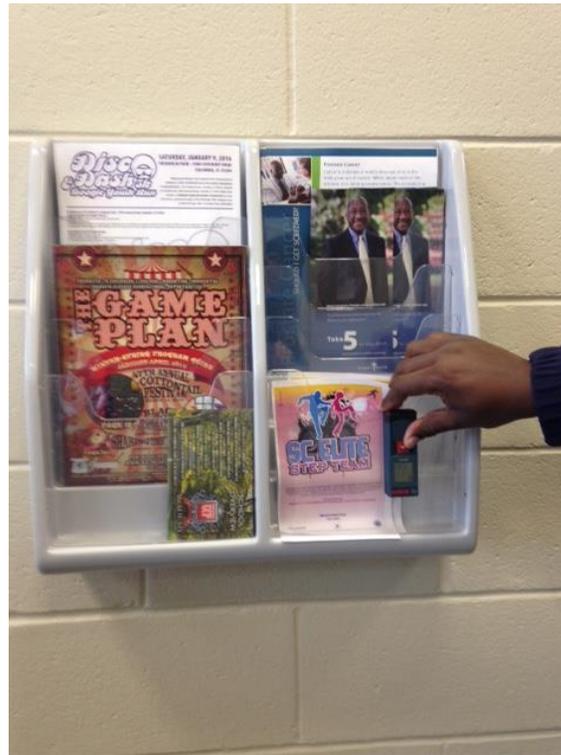
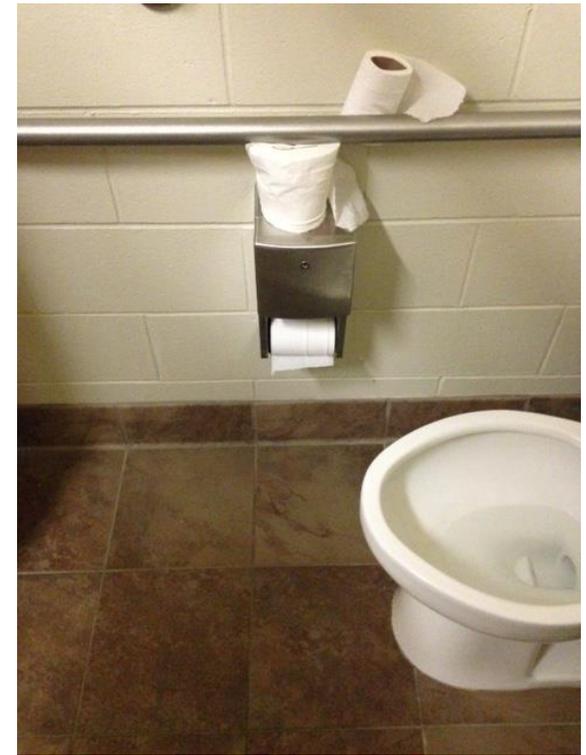
Crane Creek Gymnasium Digital Photos

Item #	Access Issue	Required Action	Completion Date
1	The operable parts of both vending machines are too high to access.	308.2.1 -Consult with vending company to see if the machines can be replaced with ADA compliant models or limit options to three with one at each height allowing people with disabilities access to the same options. 308.3.1 -Use a vending machine sign that is ADA compliant suggesting the patrons ask the staff for access and a HR policy may achieve program access.	24 months
2	The mats below the water fountains are of an inaccessible design.	302.2 Replace mats to a design without holes and with less thickness. Recommend a solid, slip resistant mat.	24 months
3	Service counter is too tall at 42".	904.4.1 -Provide counter that is 36" maximum high from the finish floor.	48 months

4	Lobby bulletin board center height is 70."	703.4.1 - Lower to center height of 60".	24 months
5	Ladies and Men's restrooms signs are 2" too high.	703.4.1 -Lower to 48" maximum from floor.	24 months
6	Wall brochure holder is 58".	308.2.1 -Lower to 48" maximum from floor.	24 months
7	No accessible surface from exit back door to parking lot.	303.2 -Install an ADA compliant ramp that is no steeper than 1:12.	36 months.
8	Code of Conduct banner is 83"	703.4.1 -Lower to 60" from floor.	24 months.
9	Men's Restroom: operable parts of soap dispenser mounted at 52".	308.2.2 -Lower the height of the soap dispenser to 48" from floor.	24 months
10	Men's restroom: Force of door pull is 13 lbs.	404.2.9 -Adjust to 5 lbs. or less	24 months
11	Men's restroom: clearance from toilet tissue holder to toilet is too short.	604.7 Move from 7 to 9" in front of toilet	24 months
12	Ladies Restroom: Operable parts of soap dispenser mounted at 52".	308.2.2 -Lower the height of the soap dispenser to 48" from floor.	24 months

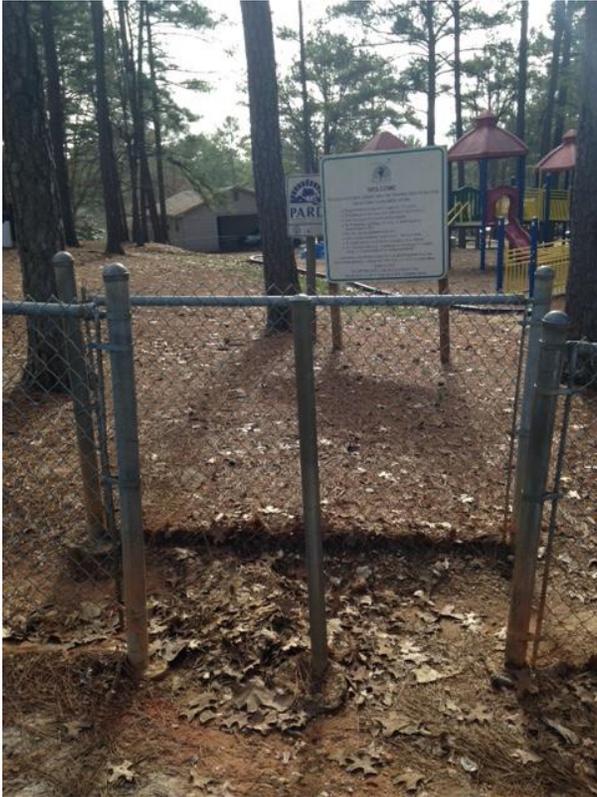
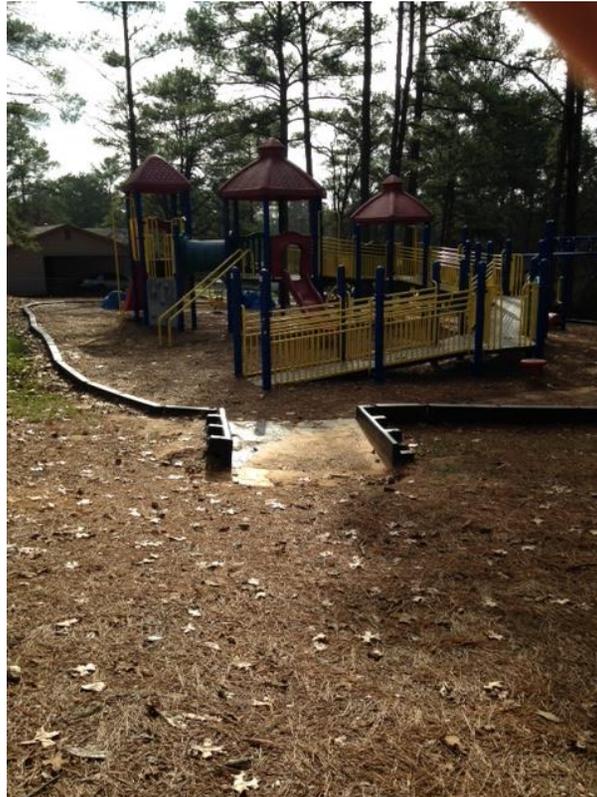
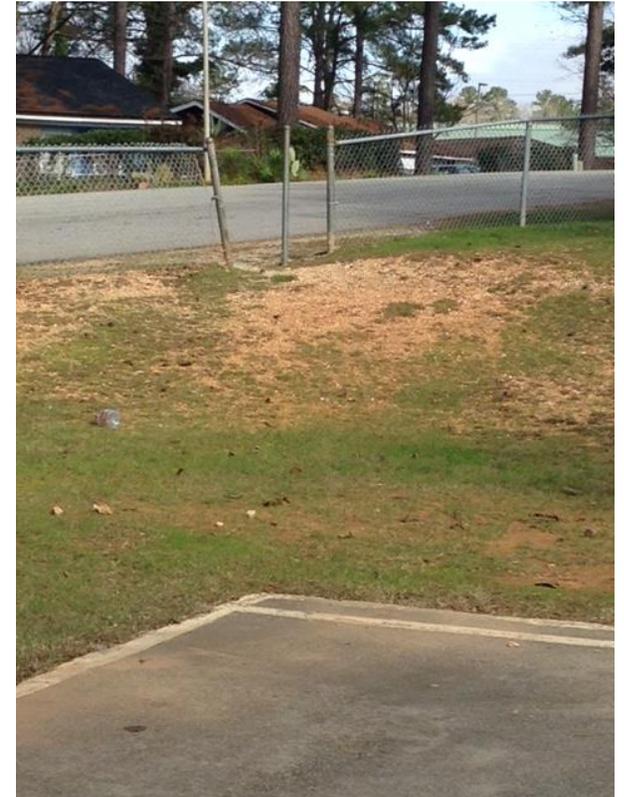
Crane Forest Neighborhood Park Digital Photos

Item #	Access Issue	Required Action	Completion Date
1	No parking or accessible parking.	502.4 - Construct parking spaces that comply with ADA standards. Floor and ground surfaces shall be stable, firm, and slip resistant.	24 months
2	Add appropriate signage indicating accessible parking.	502.6 -Add signage and emblems to spaces.	24 months
3	No path of travel or accessibility to playground, play equipment or basketball court or accessible paths of travel connecting the elements. No access through gate.	206.2.2 – Connect all outdoor elements with the closest accessible parking spaces and to each other within reasonable distances.	48 months

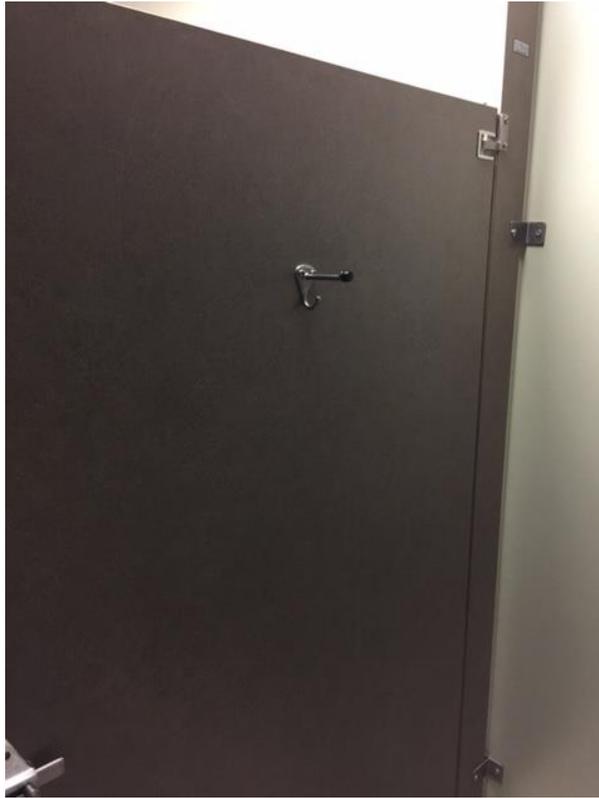
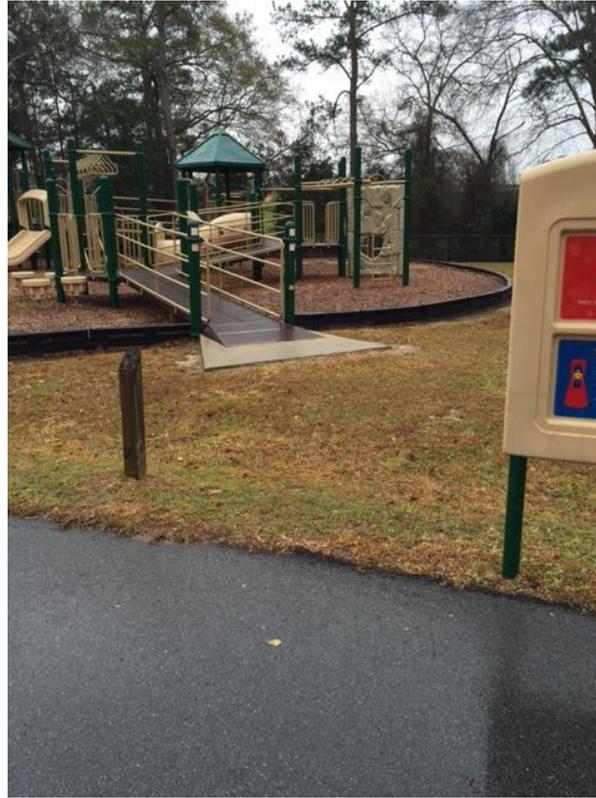
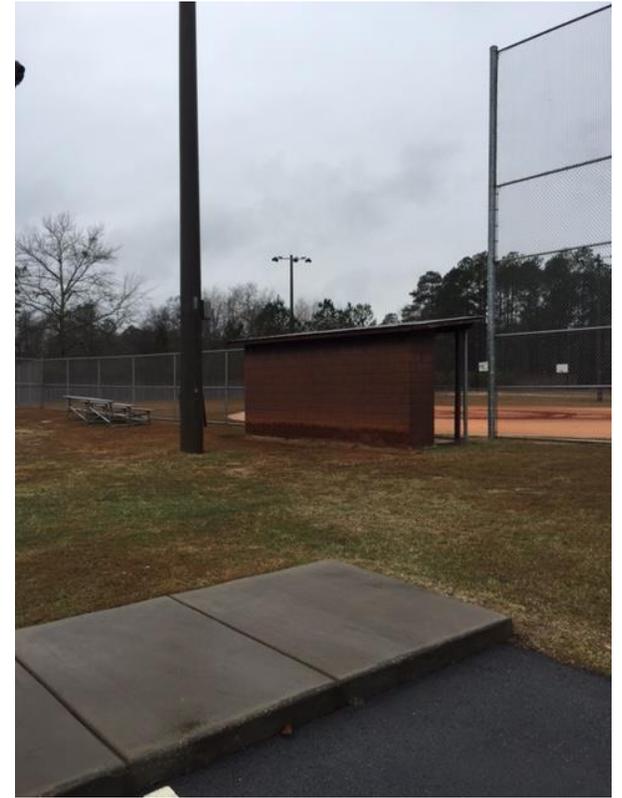
Crossroads Park Community Center Digital Photos

5	Women’s Restroom: Wheelchair stall 1)Toilet tissue & sanitary napkin holders are too close to toilet	604.8.3 Move tissue and sanitary napkin holders forward 20”;;	24 months.

6	Women's Restroom coat hook is too high;	604.8.3 -Lower coat hook to 48" from floor.	24 months
7	There is no accessible route to playground.	206.2.2 Construct accessible route to playground from walkway.	48 months
8	The benches in picnic shelter are constructed at 30".	903.5 The top of the bench should be 17" minimum and 19" maximum above the finish floor or ground.	60 months
9	Spectator benches are too high at 32".	903.5 The top of the bench should be 17" minimum and 19" maximum above the finish floor or ground.	60 months
10	There is no accessible route to the ballfields or dugouts.	206.2.2 Construct an accessible route to fields and dugouts. (At least one accessible route shall connect accessible buildings, accessible facilities, accessible elements, and accessible spaces that are on the same site.	48 months
11	The mats below the fountain are of an inaccessible design.	302.2 -Replace the mats to a design without holes and with less thickness. A solid, slip-resistant mat would be recommended.	24 months

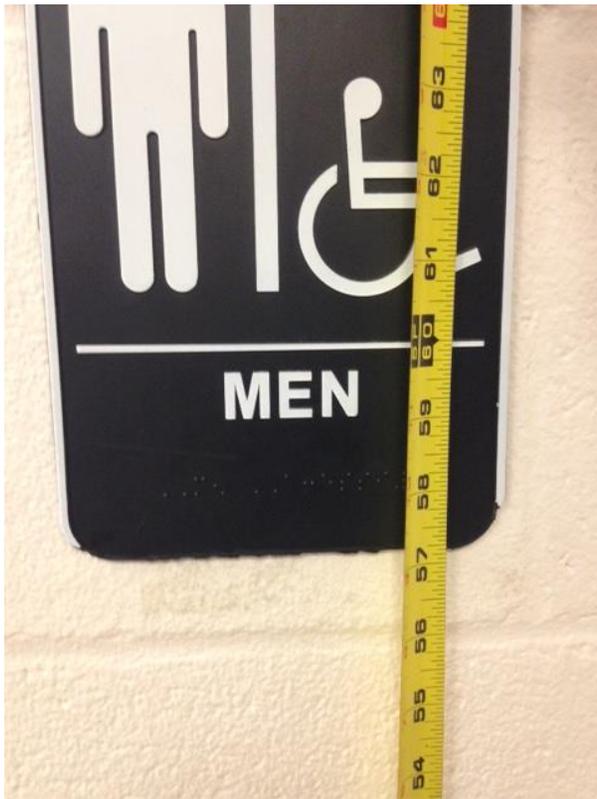
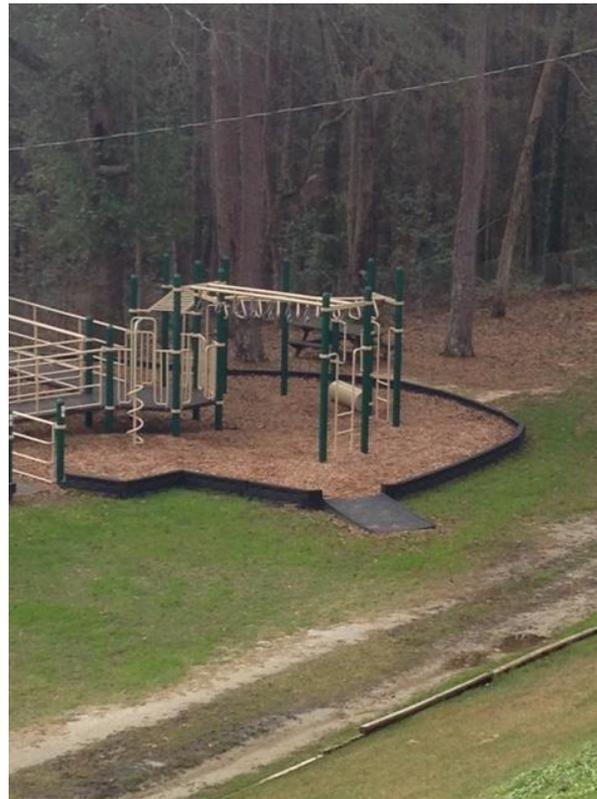
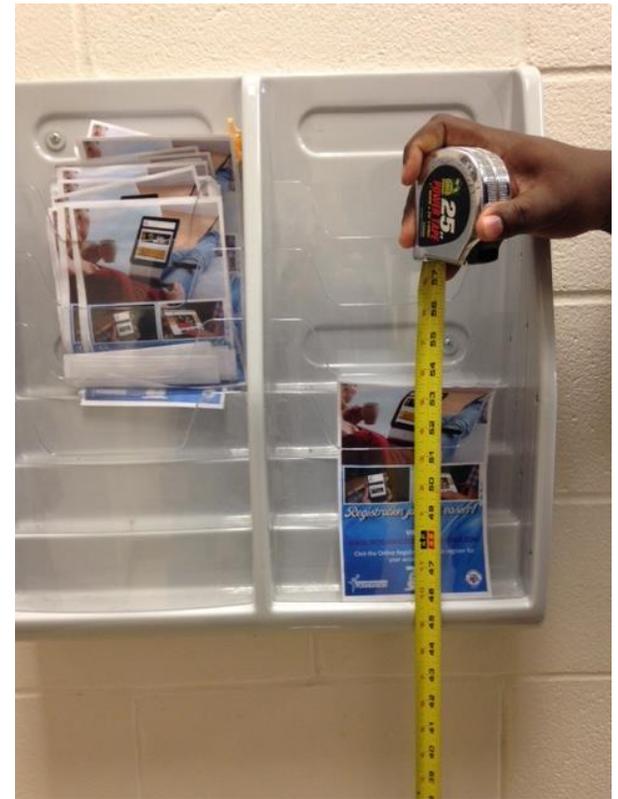
Denny Terrace Gymnasium Digital Photos

14	Brochure holder is 51".	308.2.1 -Lower holder to a maximum height of 48".	24 months
15	No accessibility to playground and walking track from parking lot.	206.2.2 -Connect all outdoor elements with the closest accessible parking spaces and to each other within reasonable distances	48 months
16	Parking lot slope is too steep.	403.3 -Cross slope of walking surfaces shall not be steeper than 1:48.	48 months
17	Pull force to open men's restroom is 10 lbs.	404.2.9 -Adjust doors to meet standard of maximum 5 lbs.	24 months
18	Pull force to open women's restroom is 8 lbs.	404.2.9 -Adjust doors to meet standard of maximum 5 lbs.	24 months
19	The mats below the water fountains are of an inaccessible design.	302.2 Replace mats to a design without holes and with less thickness. Recommend a solid, slip resistant mat	24 months

20	The operable parts of both vending machines are too high to access.	<p>308.2.1 Consult with vending company to see if the machines can be replaced with ADA compliant models or limit options to three with one at each height allowing people with disabilities access to the same options</p> <p>308.3.1 Use a vending machine sign that is ADA compliant suggesting the patrons ask the staff for access and a HR policy may achieve program access</p>	24 months
----	---	--	-----------
