Richland County Recreation Commission

Americans with Disabilities Act (ADA) Transition Plan

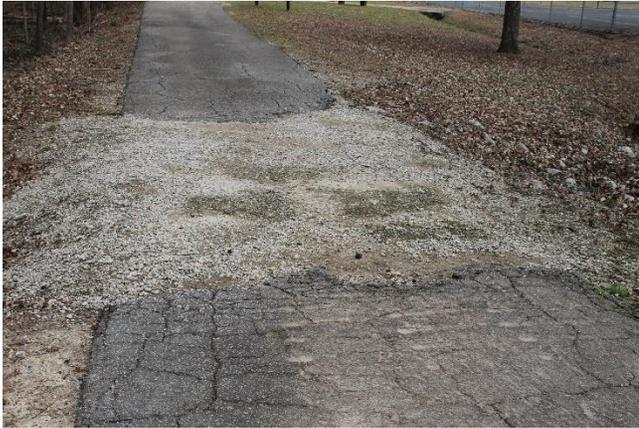
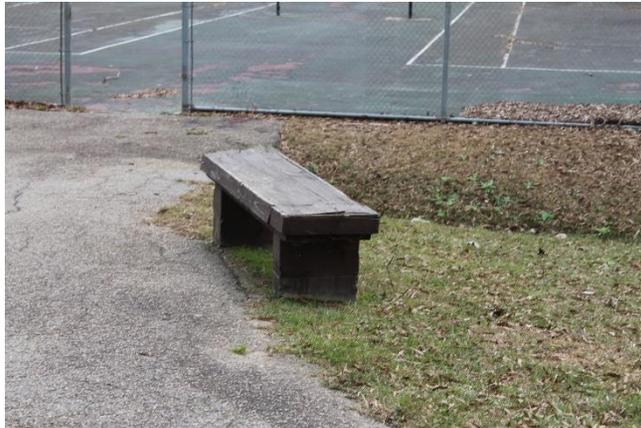
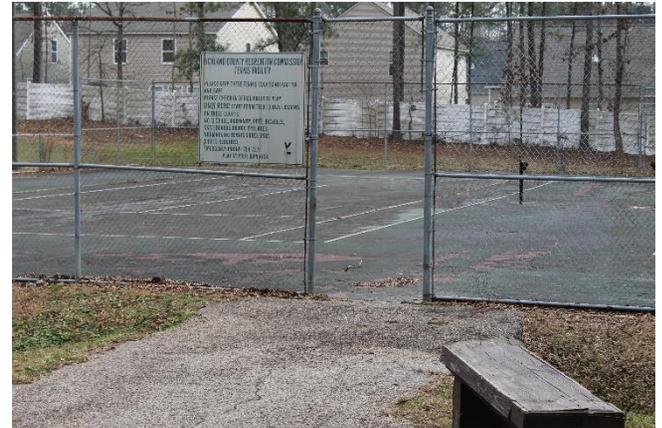
Dutch Fork Tennis Center Digital Photos

Item #	Access Issue	Required Action	Completion Date
1	No identifying signs indicating accessible parking.	502.6 –Parking space identification signs shall include the International Symbol of Accessibility. Signs shall be 60” minimum above the ground surface measured to the bottom of the sign.	48 months
2	There is no designated spectator area for the courts.		
	RECOMMENDATION FOR THIS CENTER: TRANSFORM TO A DOG PARK ACCESSIBLE FOR ALL PATRONS.

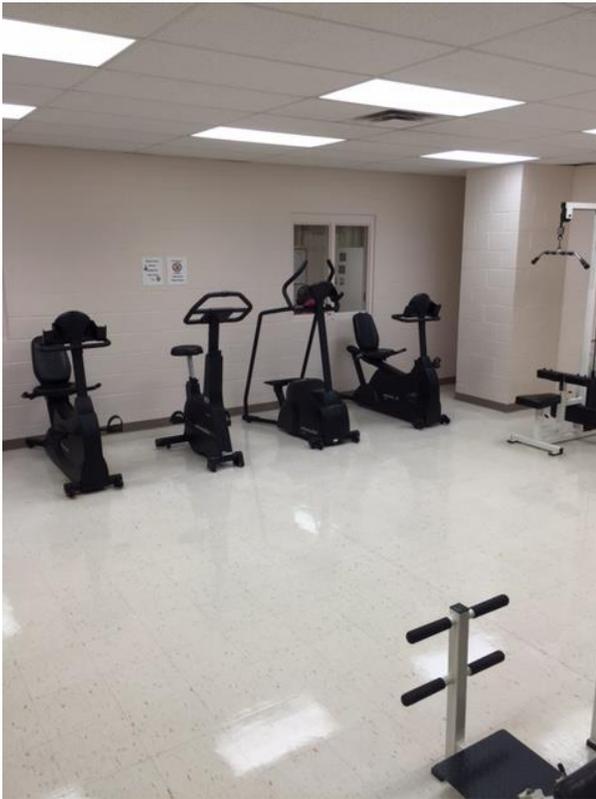
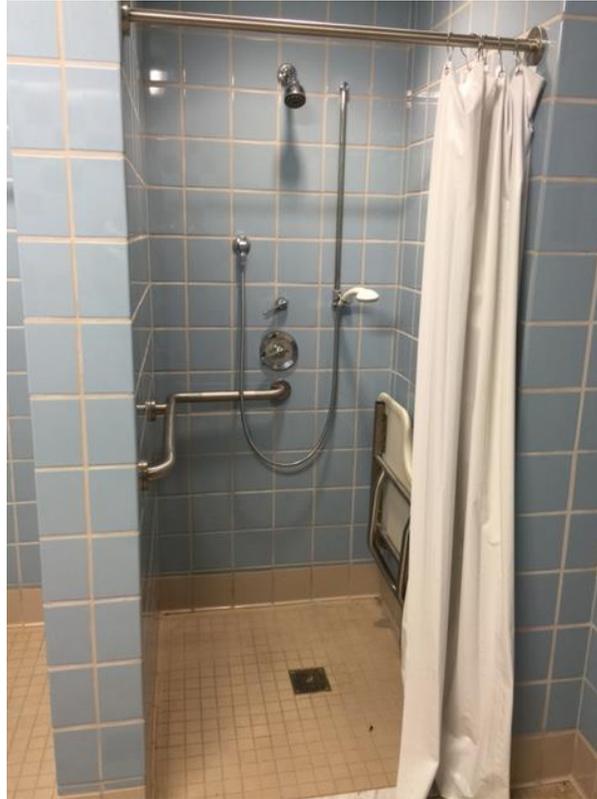
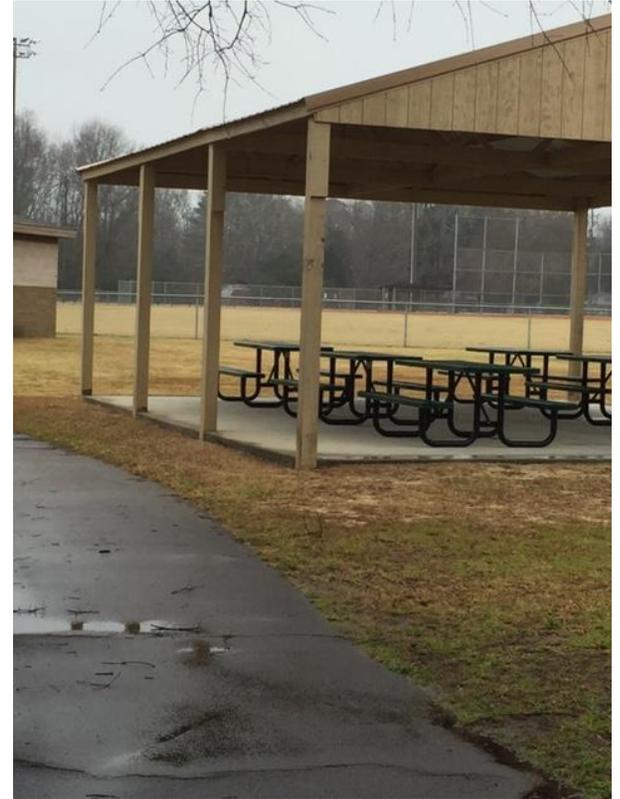
Eastover Park and Swimming Pool Digital Photos

14	Knobs are wrong type. Cannot turn with a closed fist	309.4 Replace with lever type handles	24 months
15	Paper towel dispenser is too high (52")	308.2.2 Lower the height of the paper towel dispenser to 48"	24 months
16	Soap dispenser is too high (70")	308.2.2 Lower the height of the soap dispenser to 48"	24 months
17	There is no accessibility to fitness equipment	1004.1 Make sure bench heights are within accessible limits for transfer capabilities. If so, redesign exercise areas to provide enough room to transfer or use by individuals who use wheelchairs. If not, adjust seat or bench height or obtain the accessible version of the necessary equipment	24 months

18	Both entrance doors clearance to basketball court are 29" and 33" from door latch to push bar	404.2.3 Remove the push bars from the doors and replace with paddle type handles. This will meet ADA standards as the push bar will be removed from the path of travel	24 months
19	Pool House- No signage inside building identifying rooms	703.1 Install signs with visual and tactile characters that are ADA compliant	24 months
20	Toilet paper dispenser in accessible toilet compartment needs to be moved	604.7 Move holder to 7"-9" in front of the water closet	24 months
21	No accessible routes to picnic shelters (2)	206.2.2 Develop accessible paths of travel to picnic shelters from recreation center and parking lot	48 months
22	Playground- Fill material is not accessible	1008.2.6.1 Replace playground material with one that meets accessibility and safety standards	60 months

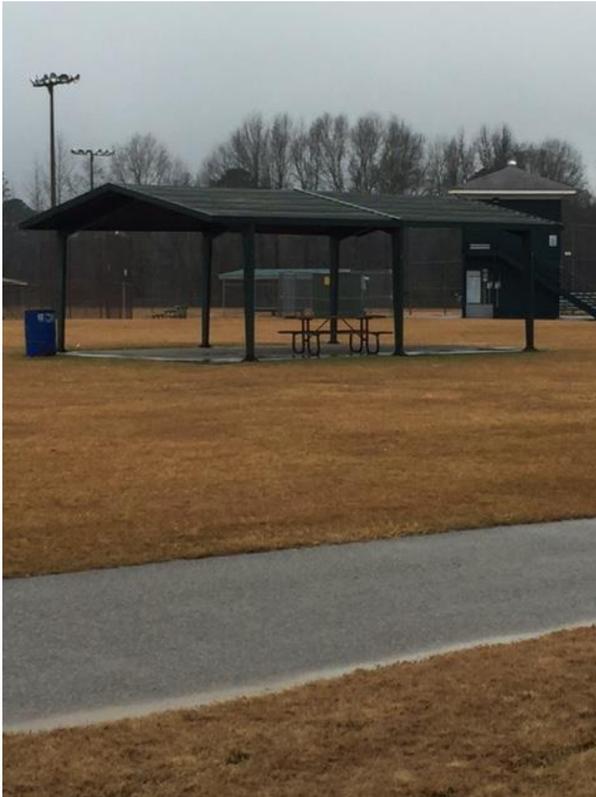
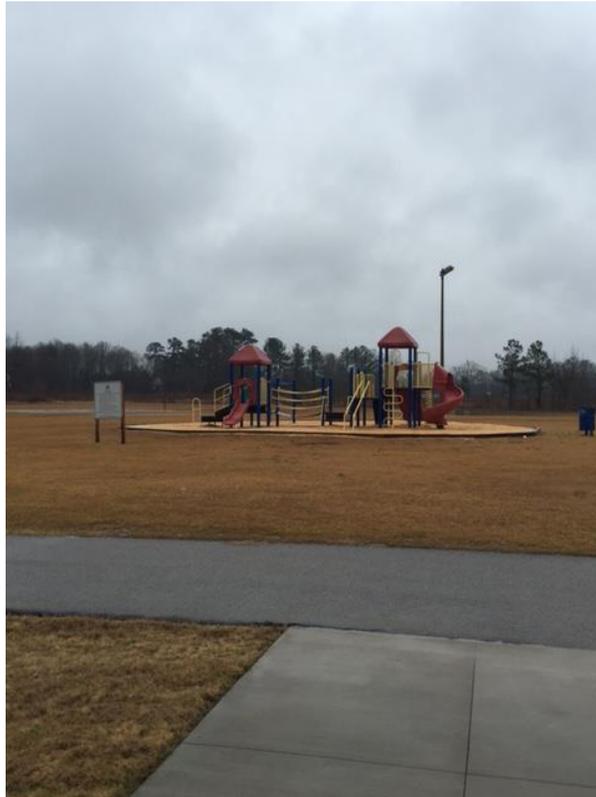
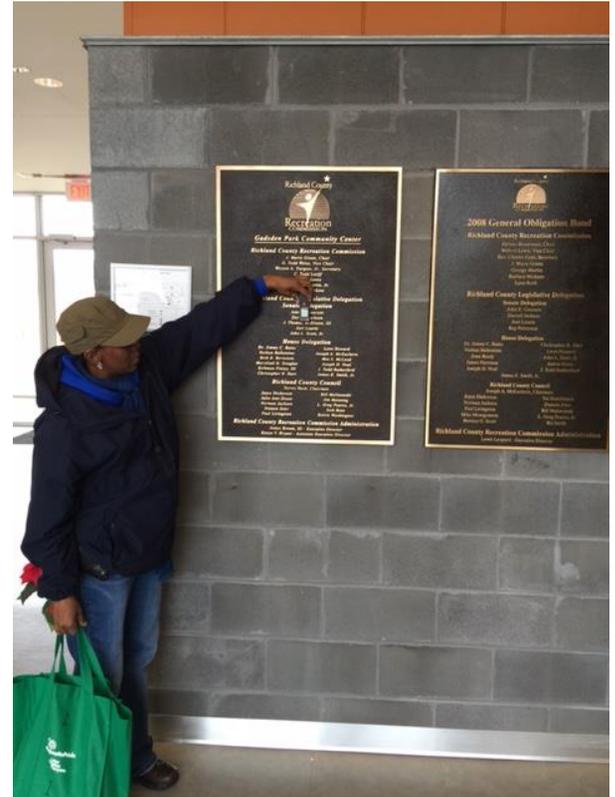
Gadsden Park Community Center Digital Photos

Item #	Access Issue	Required Action	Completion Date
1	The mats below the water fountains are of an inaccessible design.	302.2 Replace mats to a design without holes and with less thickness. Recommend a solid, slip resistant mat.	24 months
2	Occupancy (68") and RCRC signs (64") (permanent) are too high-	703.4.1 -Lower to maximum of 48".	24 months
3	Soap dispenser in ladies room is 46"	308.2.2 -Lower to 44"	24 months
4	Sanitary napkin holder is too close to toilet.	604.7 -Move dispenser 7" to 9" maximum in front of toilet measured to the centerline of the dispenser.	24 months
5	Kitchen counter is 36".	308.3.2 -Counter should be lowered to 34".	48 months
6	No accessible path of travel to playground or picnic shelter.	206.2.2 -Connect all outdoor elements with closest accessible parking spaces and to each other within reasonable distances.	48 months

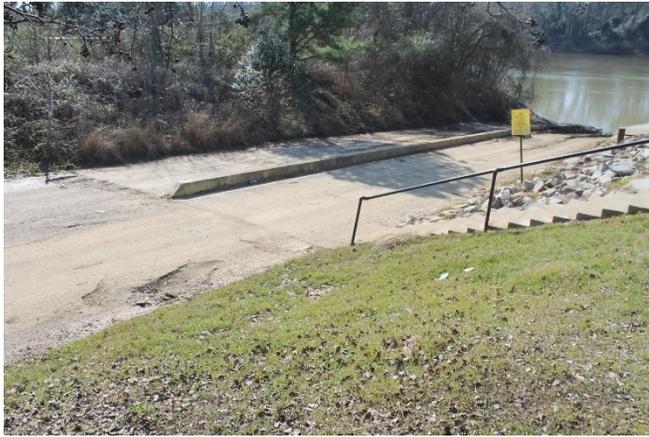
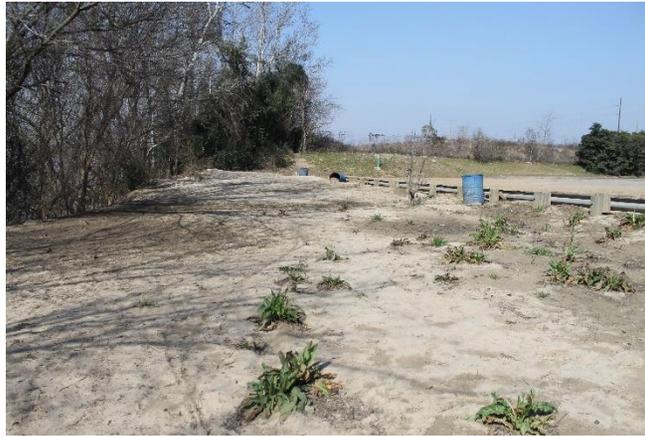
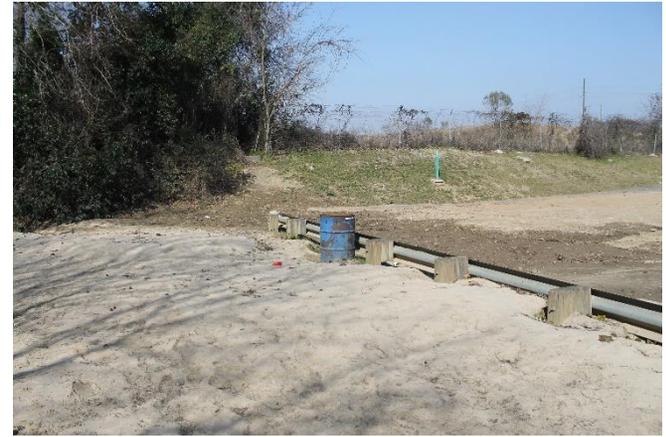
Jordan Boat Ramp Digital Photos

Item #	Access Issue	Required Action	Completion Date
1	No access to docks.	206.2.2 -At least one accessible route shall connect accessible buildings, facilities, elements and spaces that are on the same site.	48 months
2	No accessible parking or signage.	502.1, 502.2, 502.3, 502.3.1, 502.7 -Construct parking spaces with 1 accessible space for every 25 spaces. Accessible spaces 96" minimum width for cars, and 132" minimum width for vans. Access aisles should be 60" minimum width. Proper pole mounted signage is required with stenciled logo on the pavement. Ground surfaces shall be stable, firm, and slip resistant. Parking spaces and access aisles shall be designed so that cars and vans, when parked, cannot obstruct the required clear width of adjacent accessible routes.	24 months
3	No spectator viewing area.	206.2.2 -At least one accessible route shall connect accessible buildings, facilities, elements and spaces that are on the same site. Clean and pave parking lot.	48 months

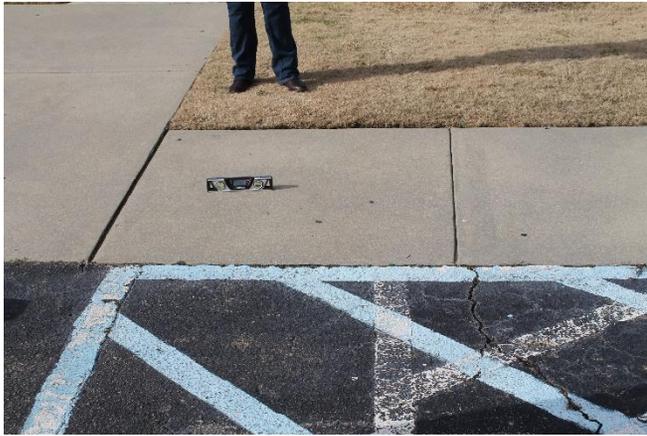
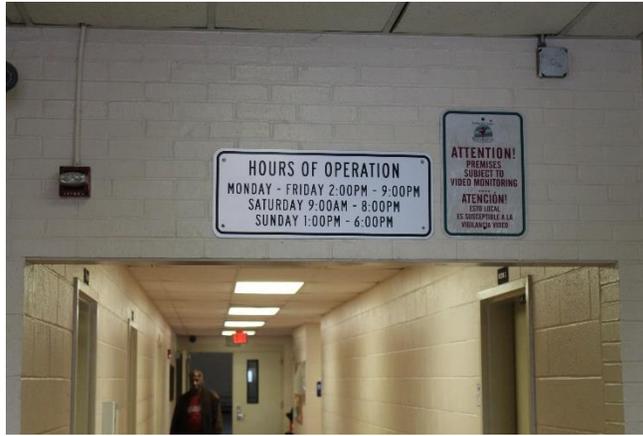
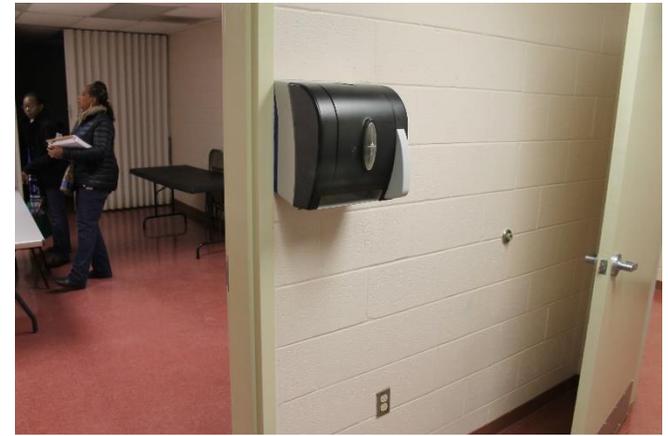
Killian Park Digital Photos

7	The operable parts of both vending machines are too high to access.	308.2.1 Consult with vending company to see if the machines can be replaced with ADA compliant models or limit options to three with one at each height allowing people with disabilities access to the same options. 308.3.1 Use a vending machine sign that is ADA compliant suggesting the patrons ask the staff for access and a HR policy may achieve program access.	24 months
8	The mats below the water fountains are of an inaccessible design.	302.2 Replace mats to a design without holes and with less thickness. Recommend a solid, slip resistant mat.	24 months
9	Brochure holder is 51".	308.2.1 If unobstructed, lower to 48" and place the same materials in the lower compartments as are in the top compartments.	24 months

10	Kitchen: Knobs are round and not accessible.	309.4 Replace with lever style that can be turned on with a close fist.	24 months
11	Building lacks signage on doors.	216.2 Replace with signs that include raised lettering or braille.	24 months
12	Counter height is too high at 36".	308.3.2 Lower counter to ADA standard of 34" max.	48 months
13	High reach paper towel dispenser-52".	308.2.2 Maximum unobstructed high reach is 48".	24 months
14	Soap dispenser is too high.	308.2.2 Lower soap dispenser to 48" maximum.	24 months
15	Permanent office signs are too high and do not have braille or raised/recessed lettering.	703.4.1 Mount at a height of 60" center.	24 months
16	Front entrance door opening force is more than 5.2 lbs.	404.2.9 Adjust door closers so that less than 5 lbs. of force is required to open the door	24 months
17	Meeting Room 1B: Exit door has an inaccessible drop off.	303.2 Install a small ADA compliant ramp that is no steeper than 1:12	36 months

18	Restrooms: Ladies: Stall door hook is mounted too high.	604.8.3 Lower door hook so that it falls between 40 and 48" from the floor.	24 months
19	Accessible toilet compartment door is 31".	404.2.3 Increase width to minimum 32".	36 months
20	Path of travel is narrow.	403.5.1 Recommend eliminate one toilet and make the entire stall ADA compatible	60 months
21	Soap dispenser and paper towel holders are high.	308.2.2 Lower dispensers between 40 and 48" from floor.	24 months
22	Men's: One urinal is too high at 21"	605.2 Lower so urinal is 17" which is the maximum height to be ADA compliant	48 months

23	Stall door hook is mounted too high.	604.8.3 Lower door hook so that it falls between 40 and 48" from the floor.	24 months
24	Wheelchair turning radius in accessible toilet compartment is narrow.	403.5.2 Recommend eliminate one toilet and make the entire stall ADA compatible	60 months
25	Soap dispenser and paper towel holder are high.	308.2.2 Lower dispensers between 40 and 48" from floor.	24 months
26	Exit door located by gym opening force is more than 7 lbs.	404.2.9 Adjust door closers so that less than 5 lbs. of force is required to open the door	24 months
27	Baseball fields: No clear path of travel to baseball fields, dugouts, or port a johns	206.2.2 Create accessible paths that connect all outdoor elements with the closest accessible parking spaces and to each other within reasonable distances	60 months

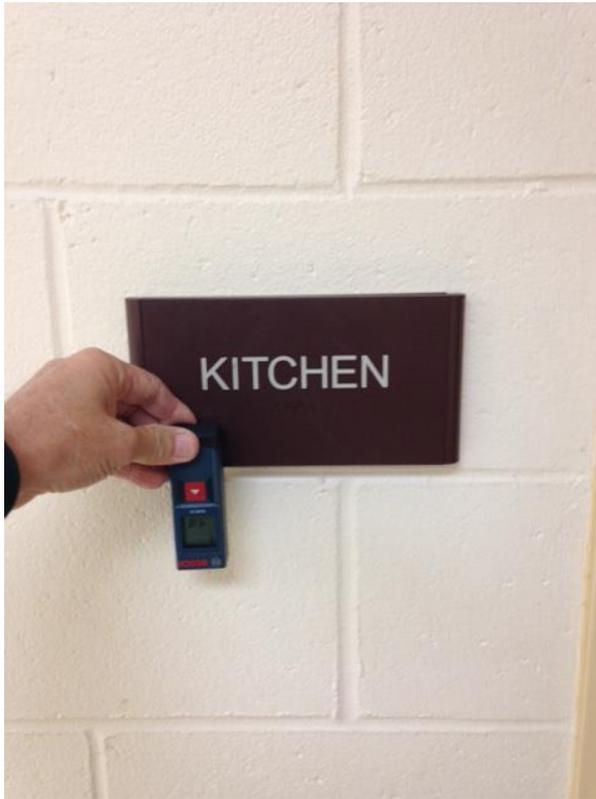
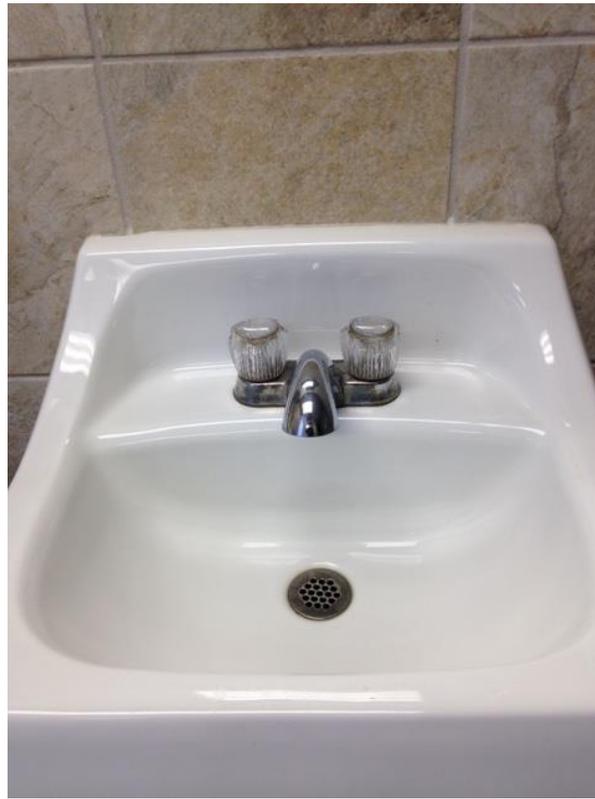
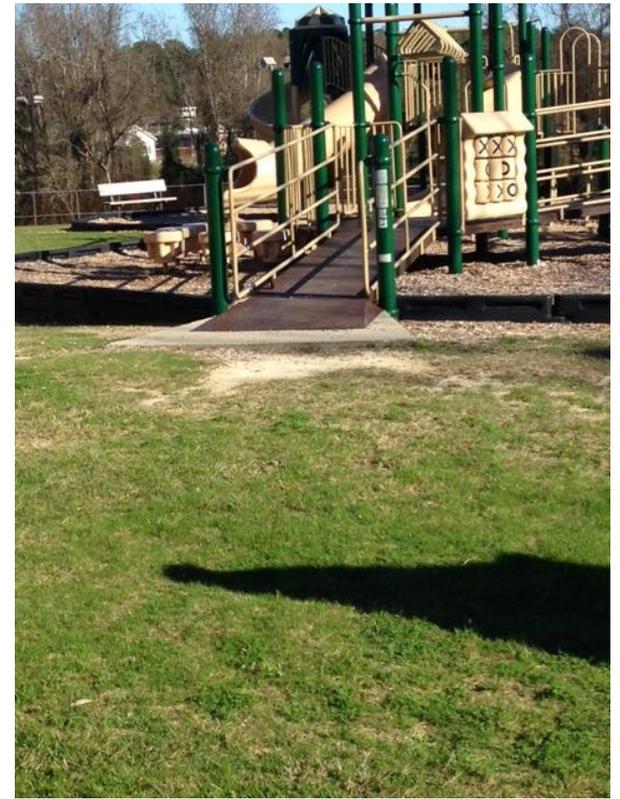
Meadowlake Park Digital Photos

19	Kitchen- soap dispenser is too high (62")	308.2.2 Lower the height of the soap dispenser to 48"	24 months
20	Kitchen- Counter is 36" high	308.3.2 Counter should be lowered to 34"	48 months
21	Kitchen- light switches are too high (50")	308.2.1 Have to lower light switch to 48"	24 months
22	Parking spaces- 136 spaces and 9 are handicap accessible.	502.6 need to add 7 signs that are in compliance with ADA standards	24 months
23	Handicap spaces (access aisles) only 46" wide	502.3.1 Widen spaces to 60"	24 months
24	Handicap spaces near picnic shelter need International Symbol of Accessibility on pavement and access spaces	502.6 Need to add signage and emblem to spaces	24 months
25	Not enough landings on path from parking lot to walking track	405.7 Add a landing at the top and bottom of the path	60 months
26	No accessible route baseball fields or playground	206.2.2 Connect all outdoor elements with the closest accessible parking spaces and to each other within reasonable distances.	48 months

27	Vending machine- the operable parts of the vending machines are too high to access	308.2.1 Consult with vending company to see if the machines can be replaced with ADA compliant models or limit options to three with one at each height allowing people with disabilities access to the same options	24 months
28	Mat's under water fountain are in an inaccessible design	302.2 Mats should be replaced with mats that are designed without holes and with less thickness. A solid, slip-resistant mat is recommended.	24 months

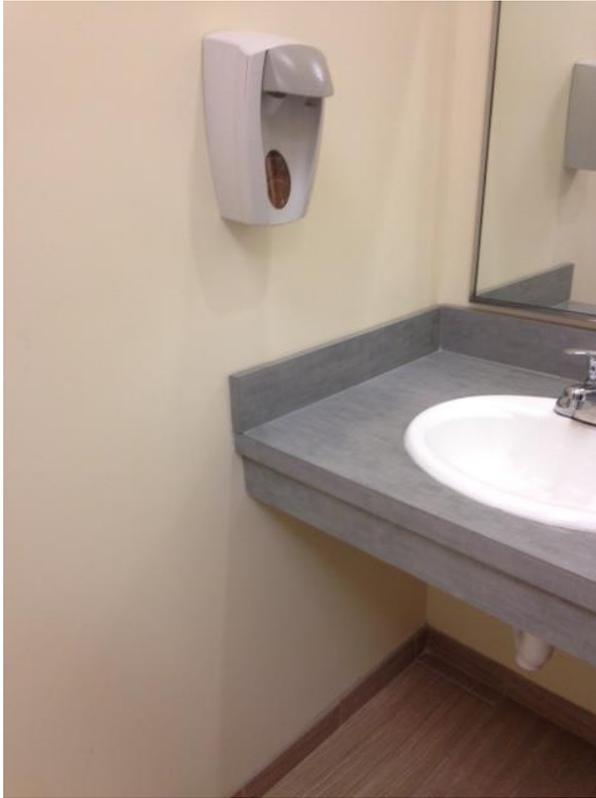
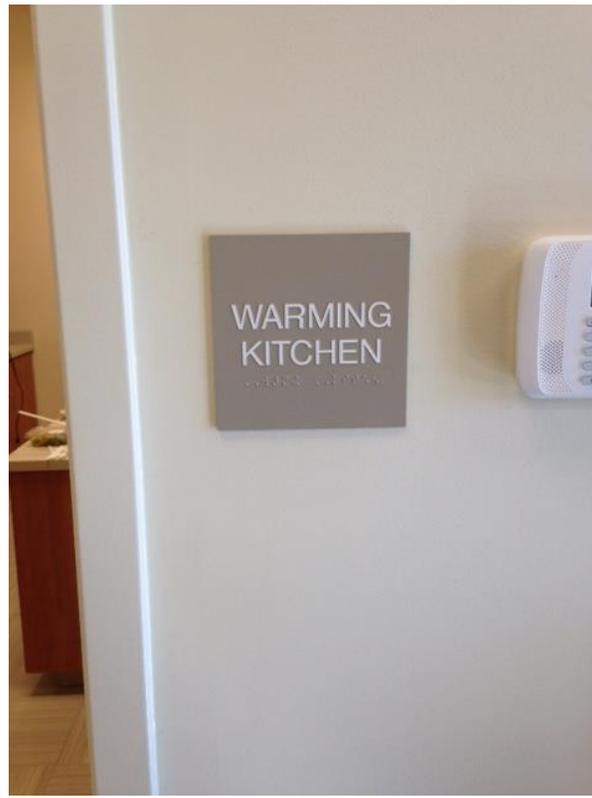
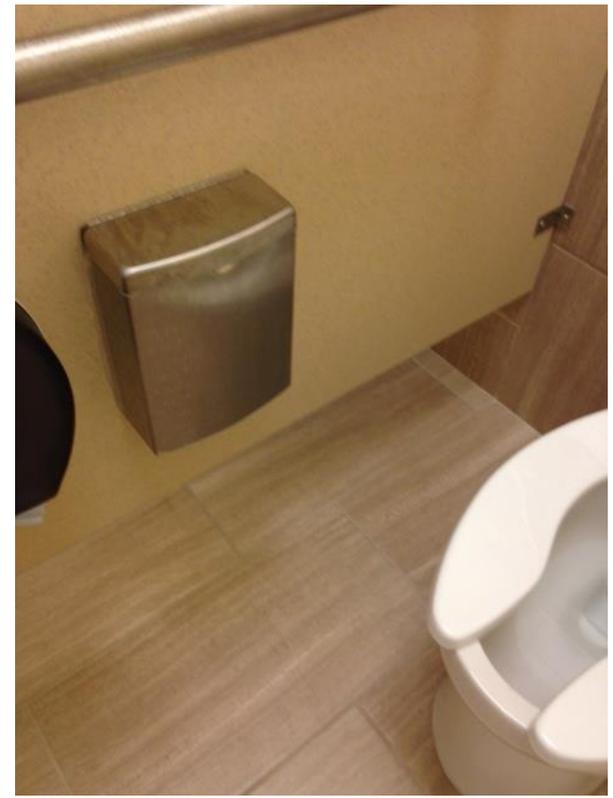
Newcastle/Trenholm Acres Community Center Digital Photos

Item #	Access Issue	Required Action	Completion Date
1	Men's Restroom- Soap Dispenser is too high at 54"	308.2.2 Lower the height of the soap dispenser to 48"	24 months
2	Men's Restroom- Wheelchair accessible compartment is 1" short in width and 2" short in length	604.8.1.1 Widen stall too allow 60" in width and 59" in depth	60 months
3	Women's Restroom- Soap dispenser is too high at 55"	308.2.2 Lower the height of the soap dispenser to 48"	24 months
4	Women's Restroom- Wheelchair accessible compartment's sanitary holder is too close the toilet	604.7 move holder to 7"-9" in front of the water closet	24 months
5	Mat's under water fountain are in an inaccessible design	302.2 Mats should be replaced with mats that are designed without holes and with less thickness. A solid, slip-resistant mat is recommended.	24 months
6	Braille on signs are too high (50")	703.3.2 Shave down signs so that braille is 3/8 inch from the border of the sign	60 months

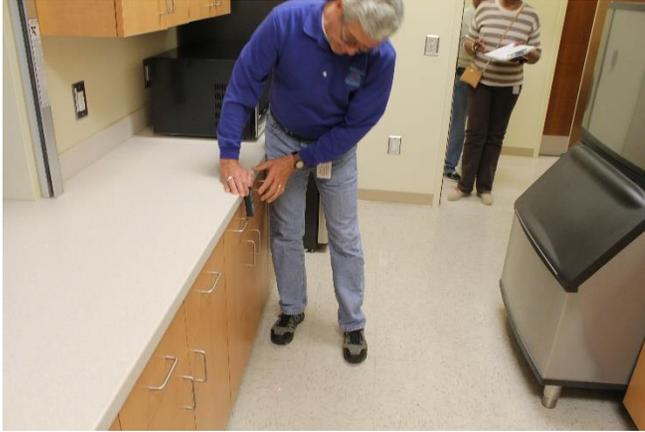
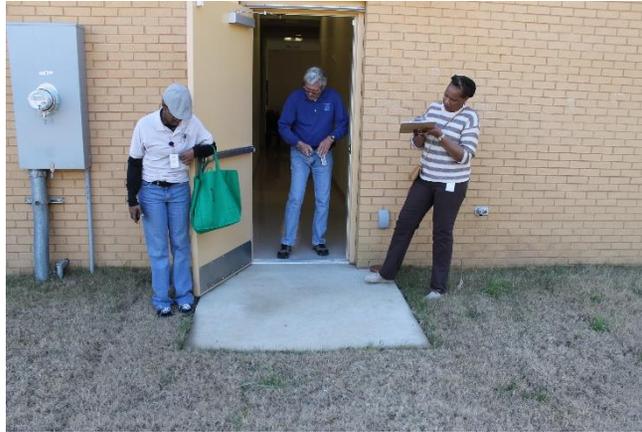
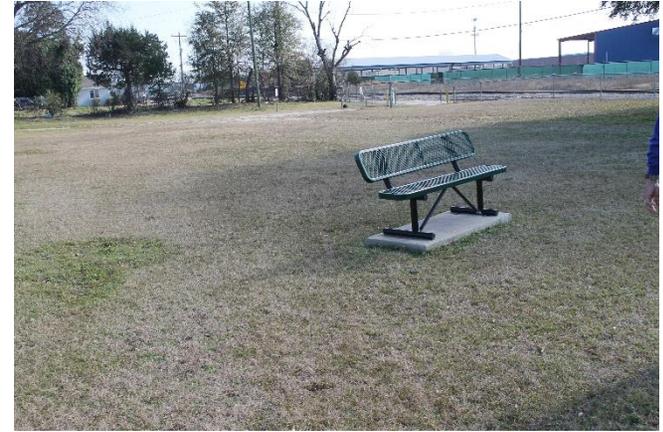
Perrin Thomas Community Center Digital Photos

Item #	Access Issue	Required Action	Completion Date
1	Signs on the men’s and women’s restrooms are too high – 52”.	703.4.1 -Lower signs to maximum height of 48”.	24 months
2	The operable part to the soap dispenser is 53” in the men’s restroom.	308.2.2 -Lower operable parts of dispenser to maximum height of 48”.	24 months
3	Coat hook is too high in the men’s restroom.	604.8.3 Lower to 48” maximum.	24 months
4	Toilet tissue dispenser in men’s and ladies restroom is too close to the toilet.	604.7 - Shall comply with 307.4 and be 7” to 9” maximum in front of water closet measured to the centerline of the dispenser. Move dispenser 4” forward.	24 months
5	No access to all elements of playground and equipment, picnic shelter.	206.2.2 -At least one accessible route shall connect accessible buildings, facilities, elements and spaces that are on the same site.	48 months

6	Picnic Shelter: 4" step up to shelter.	303.2 -Changes in level of ¼" high maximum shall be permitted to be vertical. Install a small ADA compliant ramp that is no steeper than 1:12.	48 months
7	The mats below the water fountains are of an inaccessible design.	302.2 Replace mats to a design without holes and with less thickness. Recommend a solid, slip resistant mat.	24 months

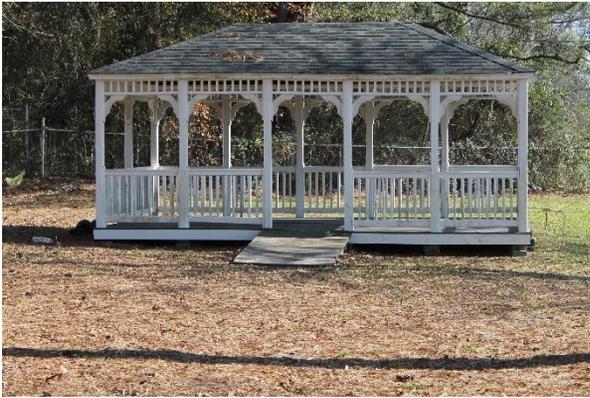
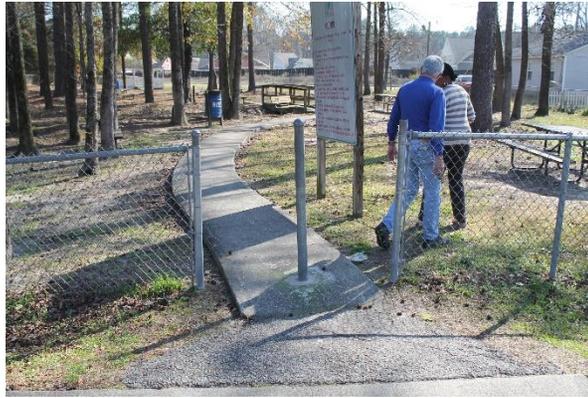
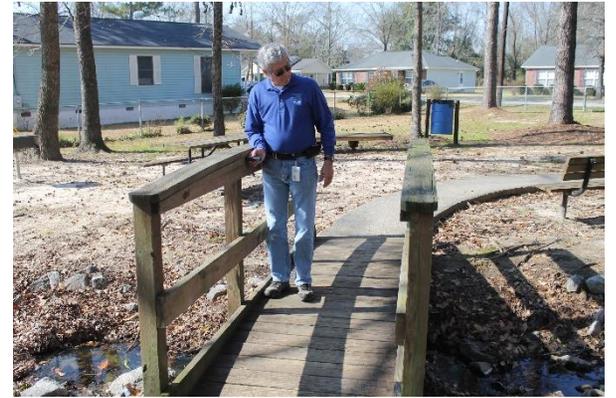
Serenity Park

Item #	Access Issue	Required Action	Completion Date
1	No parking or accessible parking.	502.4; 502.6 -Construct parking spaces that comply with ADA standards. Floor and ground surfaces shall be stable, firm, and slip resistant. Provide proper accessible parking identification.	24 months
2	No path of travel or accessibility to benches, grills, gazebo, and garbage cans.	502.4 -Add accessible paths connecting all elements to allow access for people with disabilities. Remove pole blocking wheelchair access.	48 months
3	Gate clearance is too short-28" and 27"	404.2.3 -Gate and door openings shall provide a clear width of 32" minimum.	24 months
4	Picnic shelter table is not accessible for wheelchair.	903.3, 221.2.2 -Need ADA compliant table that will accommodate a wheelchair on one end.	60 months
5	Picnic shelter benches – 18".	903.5 -The top of the bench seat surface shall be 17" minimum and 19" maximum above the ground.	60 months

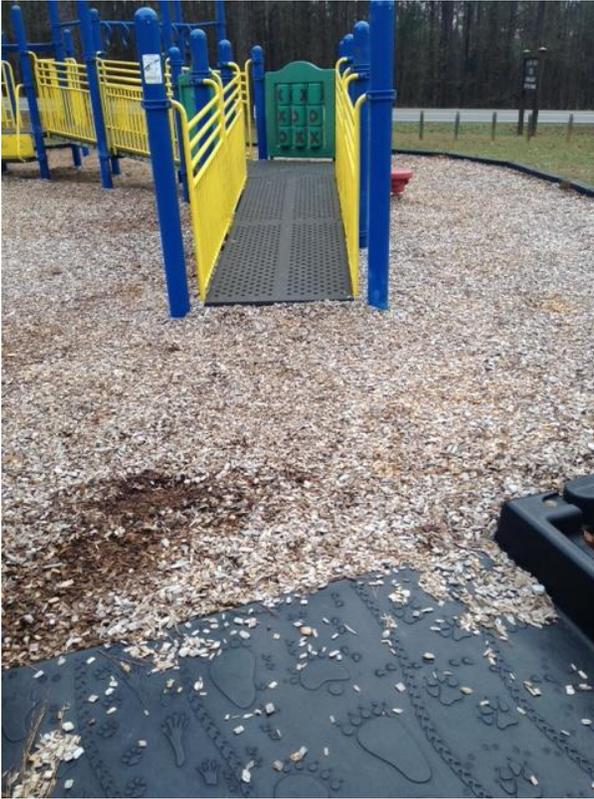
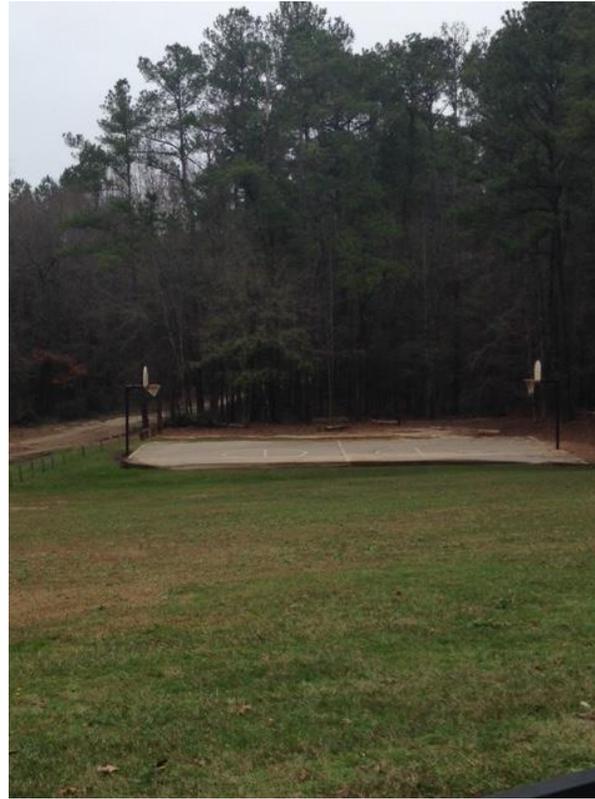
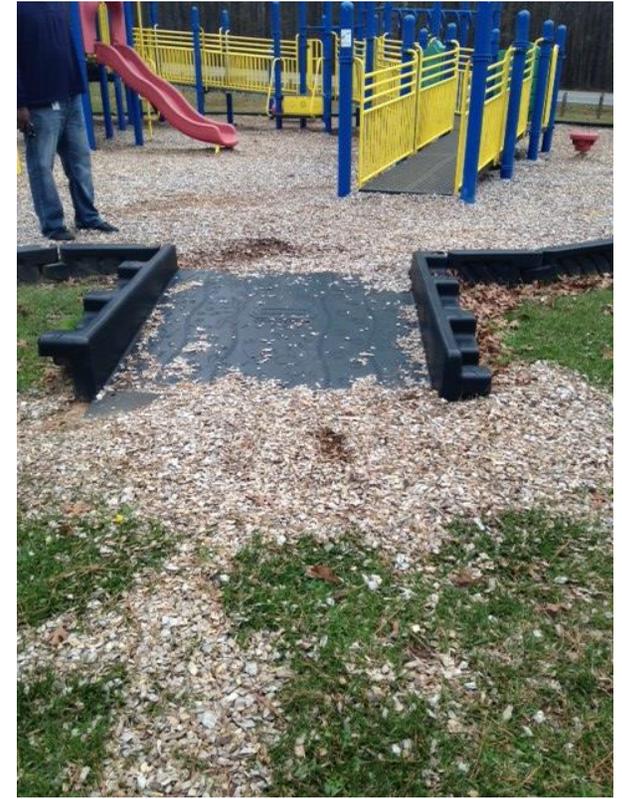
Sharpe Road Neighborhood Park Digital Photos

Item #	Access Issue	Required Action	Completion Date
1	No parking or accessible parking.	502.4 Construct parking spaces that comply with ADA standards. Floor and ground surfaces shall be stable, firm, and slip resistant.	24 months
2	Add appropriate signage indicating accessible parking.	502.6 -Add signage and emblems to spaces.	24 months
3	No path of travel or accessibility to playground, play equipment or basketball court or accessible paths of travel connecting the elements.	206.2.2 – Connect all outdoor elements with the closest accessible parking spaces and to each other within reasonable distances.	48 months

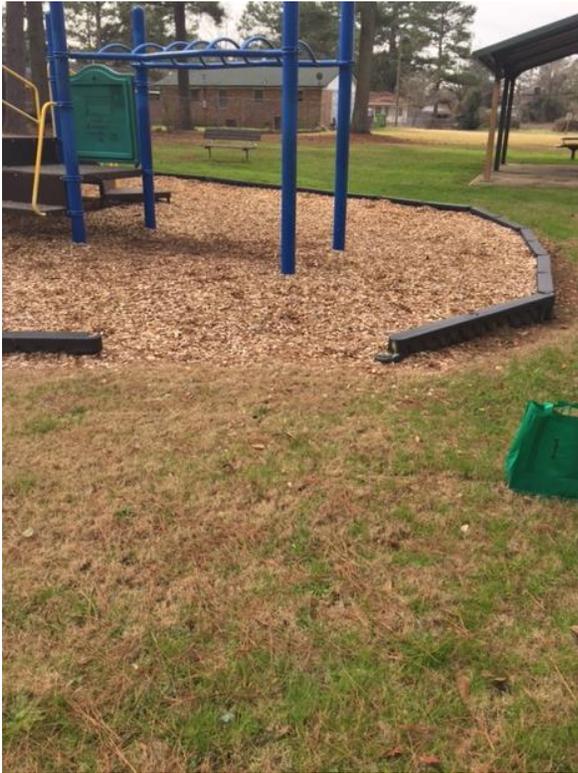
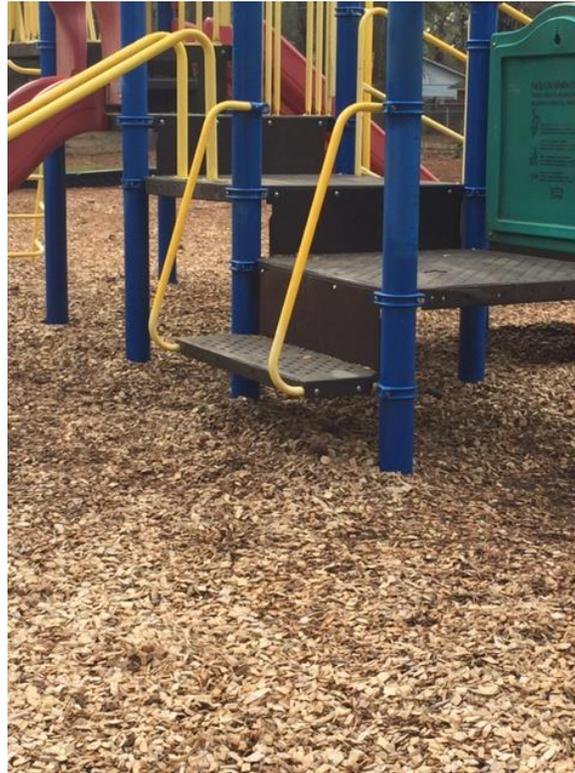
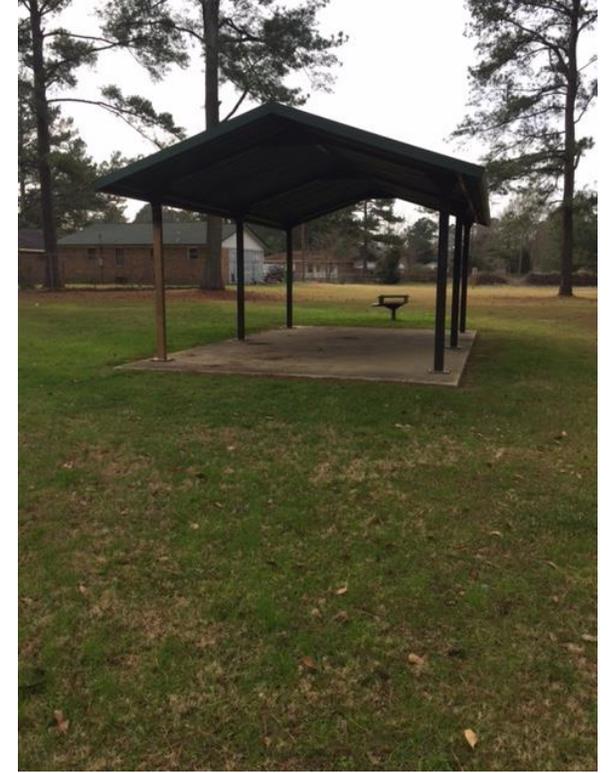
Starlite Neighborhood Park Digital Photos

Item #	Access Issue	Required Action	Completion Date
1	No parking or accessible parking.	502.4 Construct parking spaces that comply with ADA standards. Floor and ground surfaces shall be stable, firm, and slip resistant.	24 months
2	Add appropriate signage indicating accessible parking.	502.6 -Add signage and emblems to spaces.	24 months
3	No path of travel or accessibility to playground, play equipment or picnic shelter or accessible paths of travel connecting the elements.	502.4 -Pave an accessible path around the playground to connect the benches, picnic tables and trash cans to allow access to these elements for people with disabilities.	48 months
4	No tables in picnic shelter. Bullet holes in picnic shelter.	Recommendation - Repair or replace metal shelter. Install picnic tables that are accessible. The top of the bench seat surface should be between 17-19" above the finish floor or ground.	60 months

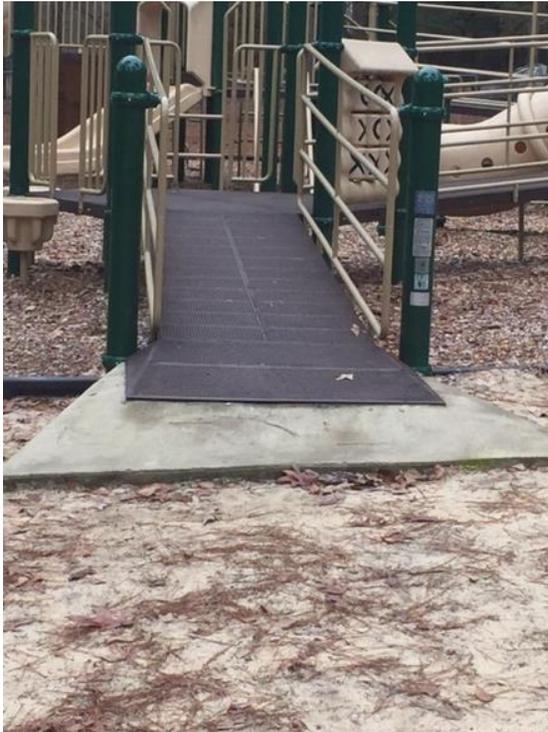
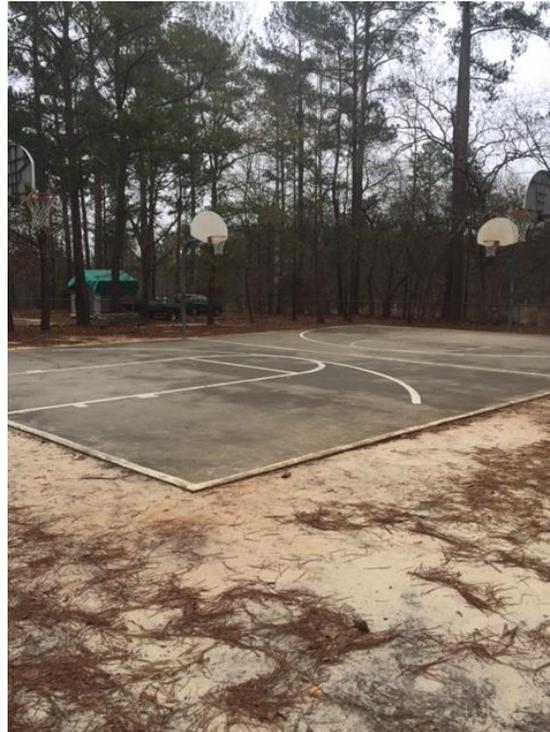
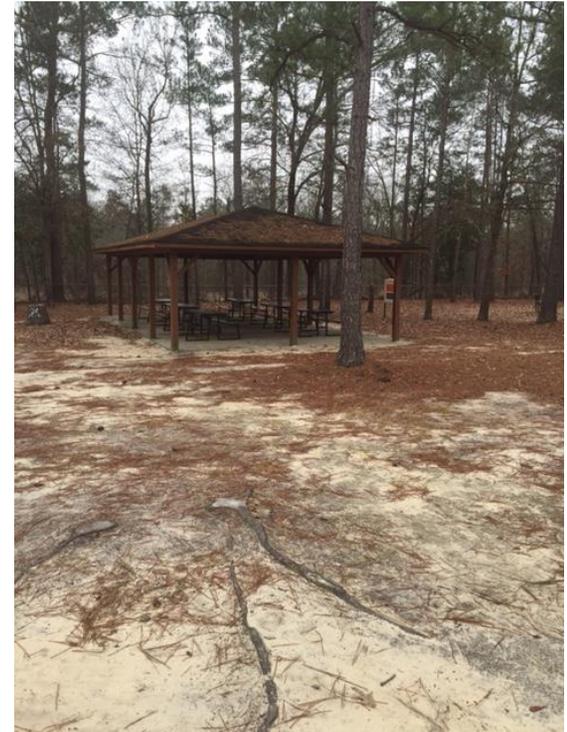
Summerhill Neighborhood Park Digital Photos

Item #	Access Issue	Required Action	Completion Date
1	Parking: No designated parking No accessible parking with proper ADA signage	502.1, 502.2, 502.3, 502.3.1, 502.7 -Construct parking spaces with 1 accessible space for every 25 spaces. Accessible spaces 96" minimum width for cars, and 132" minimum width for vans. Access aisles should be 60" minimum width. Proper pole mounted signage is required with stenciled logo on the pavement. Ground surfaces shall be stable, firm, and slip resistant. Parking spaces and access aisles shall be designed so that cars and vans, when parked, cannot obstruct the required clear width of adjacent accessible routes.	24 months
2	Gate entrance to park is 30".	404.2.3 -Door openings shall provide a clear width of 32" minimum.	24 months

3	No accessible path of travel connecting all elements- picnic shelter, basketball court and playground.	206.2.2 -At least one accessible route shall connect accessible buildings, facilities, elements and spaces that are on the same site.	48 months
4	Playground has a 3" stepdown on all sides.	303.2 -Changes in level of ¼" high maximum shall be permitted to be vertical. Install a small ADA compliant ramp that is no steeper than 1:12.	48 months
5	Basketball court has a 2" stepdown.	303.2 -Changes in level of ¼" high maximum shall be permitted to be vertical. Install a small ADA compliant ramp that is no steeper than 1:12.	48 months
6	Picnic shelter: no accessible table. Table is 16".	902.3, 221.2.2 -Need ADA compliant table that will allow a wheelchair to roll under one end.	60 months
7	Spectator benches surrounding playground are: 19", 20", 23"	903.5 -The top of the bench seat surface shall be 17" minimum and 19" maximum above the ground.	60 months

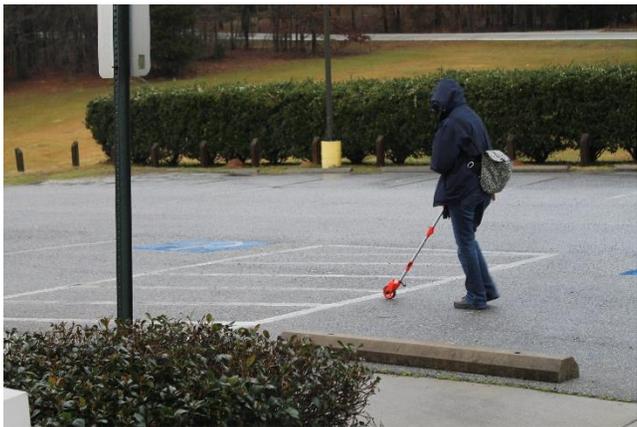
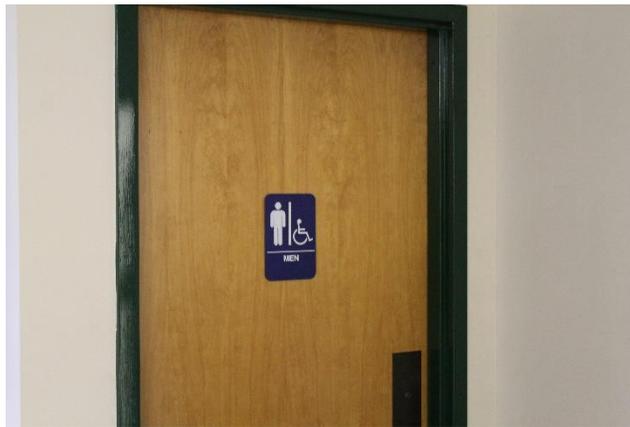
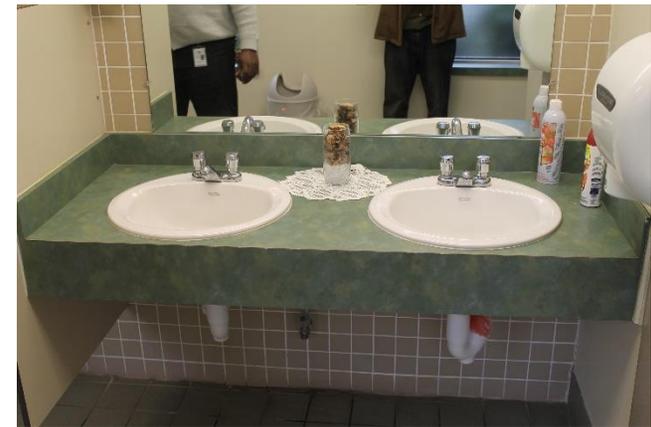
Upper Richland Community Center Digital Photos

Item #	Access Issue	Required Action	Completion Date
1	One of the accessible parking spaces is 91".	502.2 -Widen space to minimum of 96".	24 months
2	Ladies restroom sign is mounted on door.	703.4.2 -Mount on wall closes to handle at a maximum height of 48".	24 months
3	Men's restroom sign is mounted on door.	703.4.2 -Mount on wall closes to handle at a maximum height of 48".	24 months
4	One sink in women's restroom has knobs.	309.4 -Replace with lever style that can be used with a closed fist.	24 months
5	Door width to accessible stall in ladies room is 30".	404.2.3 -Door openings shall provide a clear width of 32" minimum.	24 months

6	Soap dispenser in ladies room is 60" from floor.	308.2.2 -High forward reach should be 48" maximum from floor. Relocate to sidewall.	24 months
7	Kitchen counter is 36".	308.3.2 -Counter should be lowered to 34".	48 months
8	Operable part of soap dispenser is 58" in kitchen.	308.2.2 -Lower to ADA standard of 48" maximum from floor finish. Relocate to sidewall.	24 months
9	Exit door width is 33".	404.2.3 -Door opening should provide a clear width of minimum 32".	24 months
10	The force needed to open the kitchen door is 6 lbs.	404.2.9 -Adjust door to open with a force of 5 lbs. or less.	24 months
11	Screen door is 35" wide.	404.2.3 -Door opening should provide a clear width of minimum 32".	24 months
12	Lobby bulletin board is 65" high.	703.4.1 -Bulletin board needs to be lowered to 60" center.	24 months
13	The mats below the water fountains are of an inaccessible design.	302.2 Replace mats to a design without holes and with less thickness. Recommend a solid, slip resistant mat	24 months
